Name: Joerg Teiche  
 Department: SHS DI MR QT  
 Telephone: +49 162 2176316  
 E-mail: mr\_post\_market\_surveillance.dl@siemens-healthineers.com  
 Date: April 15, 2024  
 Customer Advisory Notice MR074/23/P

## **CUSTOMER ADVISORY NOTICE**

### **Customer information about loosened screws on horizontal drive of patient table**

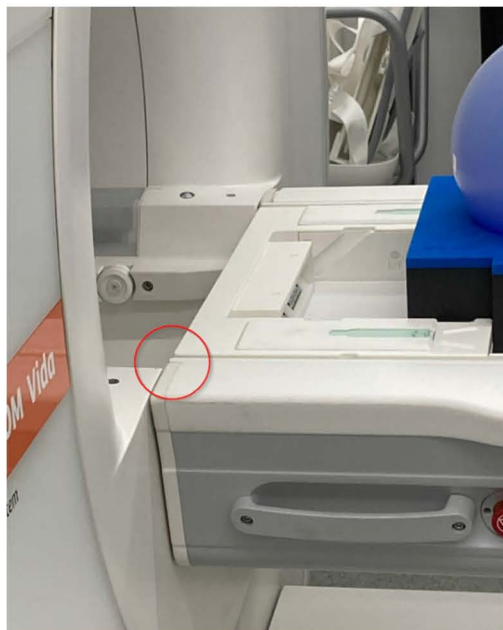
1. Move the head coil to the magnet isocenter position.
2. Move the patient table to the home position (zero position).
3. The system will show that the patient table is in the home position.
4. Visually check that the tabletop is fully in the home position, see Figure 1.
5. In case of error, there could be a deviation of up to 4 cm, see Figure 2.
6. If after visual check the tabletop is not in the home position, your tabletop is affected and must not be used for marking reference points with an external laser.

*Figure 1: Tabletop moved to home position - works as specified.*

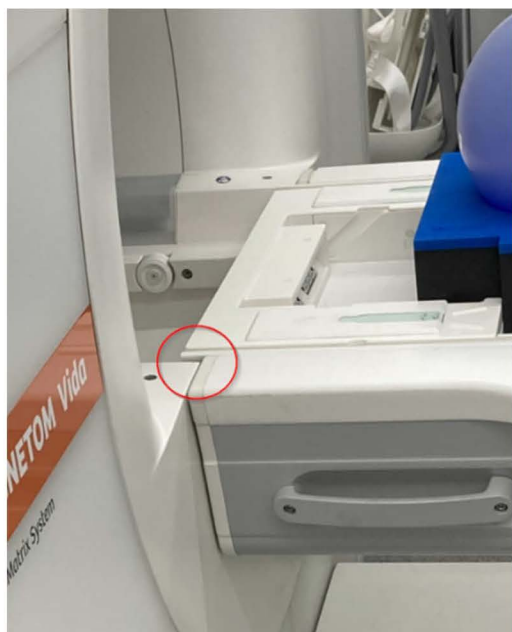
Screws inside the patient table may become loose and potentially fall off. If the screws fall off, the tabletop position will no longer correspond to the displayed position. Especially after table movement in two different directions, the displayed table position can differ by up to 4 cm.

The wrong position of the tabletop is not easily recognized by the user nor detected by the MR system, and no error message will be displayed.

*Figure 2: Tabletop moved to home position - Home position with deviation*

Siemens Healthineers will correct the issue by replacing the potentially affected screws at customer sites with the field update MR075/23/P. This replacement program is planned to start by June 2024. With the replacement, the root cause is eliminated.
