## Urgent Field Safety Notice

FSCA Ref: FSCA 2025/002  
FSN Ref: FSN 2025/002

ViennaLab Diagnostics GmbH is bringing to your immediate attention the serious incident about the product **BRAF 600/601 StripAssay®** (REF 5-560) with the following details:

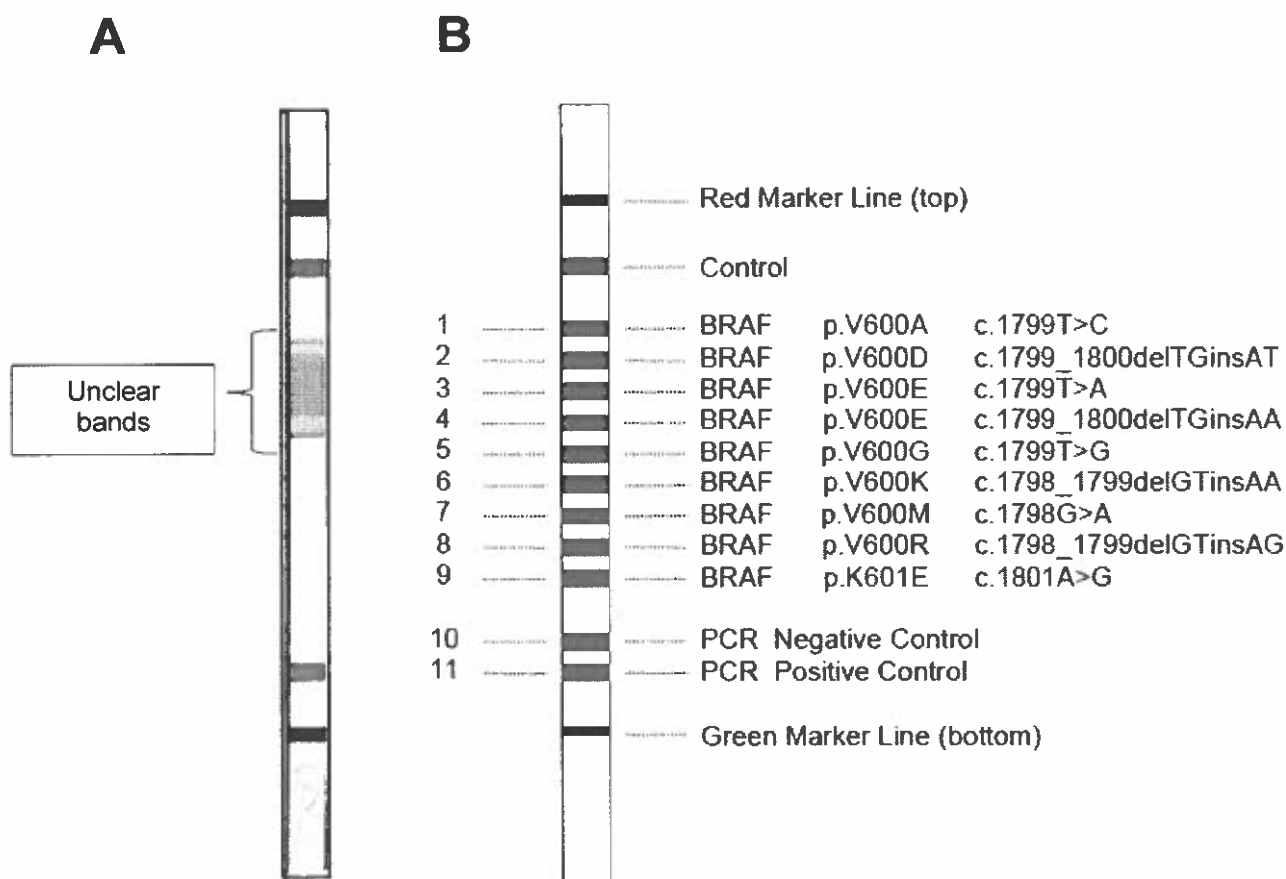
Following a single customer complaint, we identified that one Teststrip from Lot #: 09-DR-24 may produce an unclear band pattern at lines 1 to 4 after test completion when the sample is positive for one of the corresponding mutations. It is important to note that this lot has been on the market for over a year, during which 7144 Teststrips have been distributed, and we have received only one report of this issue. This indicates that the occurrence is extremely rare and isolated, and there is currently no evidence of a systematic problem affecting the lot.

Unclear bands do not lead to false positive or false negative results, but they may prevent proper interpretation of that individual Teststrip. In such cases, a repeat test may be required, which could cause a delay in obtaining the result. Users are reminded that Section VI of the IFU provides guidance for identifying unclear bands using the Collector Sheet, and Figure 3 illustrates examples of such bands. We are continuing our investigation to fully understand the root cause, and we will take any necessary actions should further complaints be received. In the meantime, the overall risk to test performance and patient safety remains extremely low, and the vast majority of tests from this lot perform as intended.

Below, on the left side (Figure 1A), is an example of unclear bands on the Teststrip after completing the test.

Below, on the right side (Figure. 1B) is the right band pattern on the Teststrip according to the IFU.

Figure 1: (A) An example of unclear bands after hybridization. (B) The Teststrip design from the current version of the IFU and the current version of the Collector Sheet.

You may continue to use the lots containing the potentially affected Teststrip Lot (Lot #: 09-DR-24).

Always follow the instructions provided in the IFU. According to Section VI (Interpretation of Results), results can be assessed using the Collector Sheet. By following the instructions and reviewing the example results in Figure 3, end users can recognize any "unclear bands" that may appear.

It is assumed the issue is extremely rare, having occurred only once; if you notice unclear bands or missing separation of bands, please repeat the test and inform your distributor with the proof of Teststrips with "unclear bands" or ViennaLab at [techhelp@viennalab.com](mailto:techhelp@viennalab.com).
