Product/Trade Name: ARTIS icono ceiling

AX022/26/S

## Customer Safety Information (CSI) for Field Safety Corrective Action

**Subject: Information regarding a possible DCS issue for ARTIS icono ceiling systems**

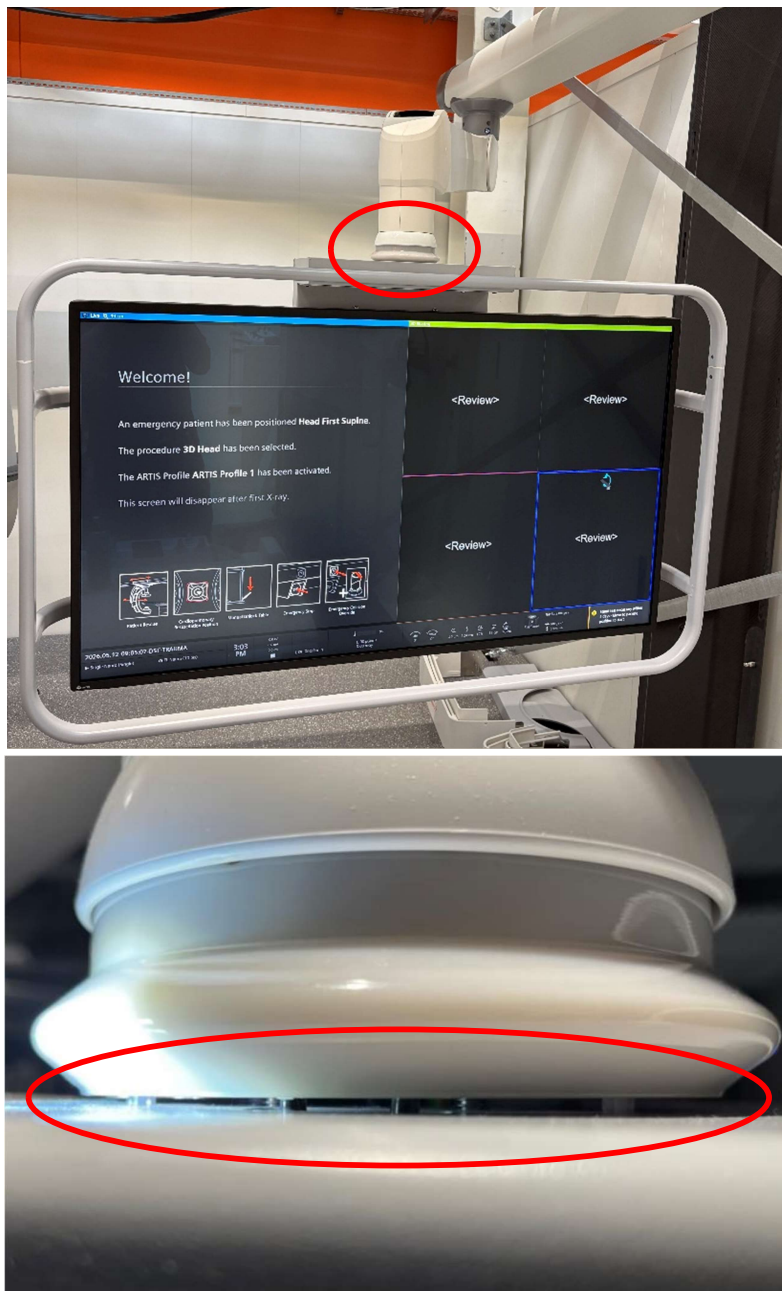
The affected part is the Display ceiling suspension (DCS Fix XL) that holds the monitor in place. Over time, some screws that keep the monitor attached may slowly become loose. This happens near the X-ray indicator light. As the screws loosen gradually, a small gap can be seen underneath the indicator light. This gap increases slowly and can be noticed over a longer period of time.

The monitor carrier is attached to the supporting arm using multiple screws, providing a high level of mechanical redundancy. If one or more screws at this connection loosen, a visible gap may appear between the monitor carrier and the X-ray indicator light. Because several screws secure the connection, the system includes built-in safety redundancy if an individual screw begins to loosen.

The screw tightening torque can be insufficient in certain practical situations. Frequent impacts against the DCS end stops may lead to a loosening of the screws.

To minimize risk, regular inspection of the gap between the monitor carrier and the ceiling-mounted arm should be performed. If a gap is observed, promptly contact our service organization for guidance. Additionally, be attentive to any unusual noises, shaking, wobbling, or other unexpected behavior during operation, as these may indicate loose screws. If you observe any such signs, limit movements of the DCS and contact our service organization immediately for further instructions.

Our service representative will correct the screwed connection of the monitor ceiling support according to the adapted specifications and instructions.
