**FSN Ref:** 2026-FSN-0000147

**URGENT Field Safety Notice**  
**Risk of Persistent Low Purge Pressure Condition**

| 1. Information on Affected Devices* | |
|---|---|
| 1. | 2. Commercial name(s)*<br>Impella CP Set with SmartAssist |
| 1. | 4. Device Model/Catalogue/part number(s)*<br>0048-0014 |

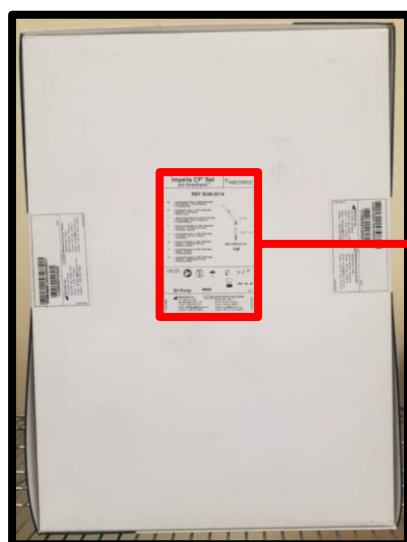
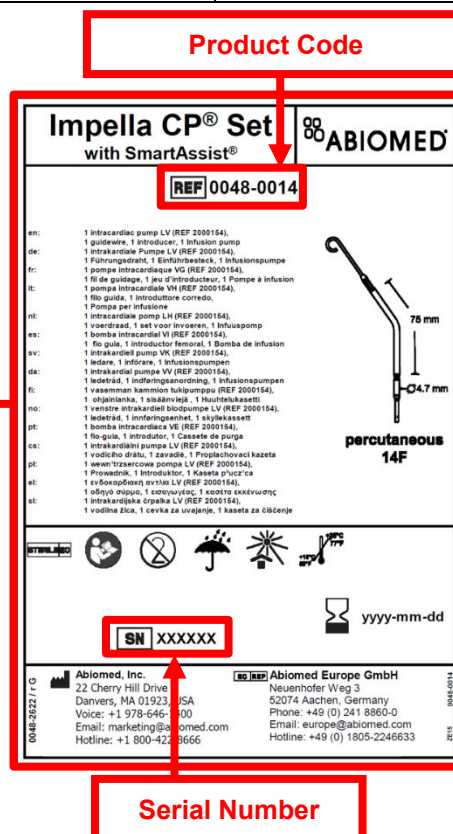
The subject devices have a label on the outer box as seen below. To identify if your units are affected by this field action, refer to the serial number (SN) on the label (red box) and check if the serial number matches the serial number(s) listed below.

| Product Code | Product Description | Impacted Serial Numbers |
|---|---|---|
| 0048-0014 | Impella CP Set with SmartAssist | 636173 (Czech Republic)<br>499250 (Norway) |

- **Immediately identify affected devices**
  - Review inventory and stock for any affected serial numbers listed in the recall notification. Verify all Impella CP devices against the provided affected serial number list. Instructions to Locate affected devices is provided above.
- **Stop using affected devices**
  - Do not use any affected Impella CP device identified in inventory.
  - Immediately quarantine affected units to prevent inadvertent use.
- **Return affected products**
  - Please contact **Abiomed** to arrange the return and replacement of the pump.
- **Maintain awareness if a device is already in use**
  - The recall is limited to specific serial numbers.
