URGENT: FIELD SAFETY NOTICE – MDS-24-5154-B

4Fr Single Lumen PowerPICC (SOLO and non-SOLO versions)

Type of Action: Product Removal

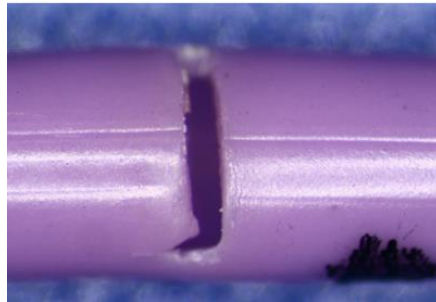
In October 2024, BD issued an advisory Field Safety Notice for unexpired lot numbers of 4Fr Single-Lumen PowerPICC Catheters (SOLO and non-SOLO versions) to inform customers about an observed increase of material fatigue leaks (Figure 1) on the 4Fr Single Lumen PowerPICC catheters in specific geographies.

BD has conducted a comprehensive investigation and has identified that three lots of resin used to extrude the tubing material exceeded our supplier's specification for a material property called Melt Flow Index (MFI). BD's investigation has shown that higher MFI could lead to increased material fatigue leaks. All of the extruded catheters meet BD specifications for dimensions and mechanical properties; however, BD is removing all product from the field that was extruded from resin that exceeded the supplier specification.

Figure 1: Example of transverse/circumferential crack in the catheter body

BD is now conducting a Field Safety Corrective Action to remove specific lots of **4Fr Single-Lumen PowerPICC Catheters** listed in Appendix 1.

- BD is removing all unexpired lots of 4Fr Single Lumen PowerPICC which exceed the supplier's specification for MFI.
- BD is notifying users that adhesive back securement systems are recommended.
- BD is notifying users that if they do use compression style securement systems, they must be sized appropriately to accommodate the reverse taper.
- BD is notifying customers to insert the catheter to as close as possible to the 0 mark, per the IFU.
- BD has been updating the product IFU with cautions related to the use of compression style securement systems around the taper region of the PICC.
- BD will provide product replacement or credit for all destroyed products.
- BD will continue investigating this issue and will follow up with any additional actions.

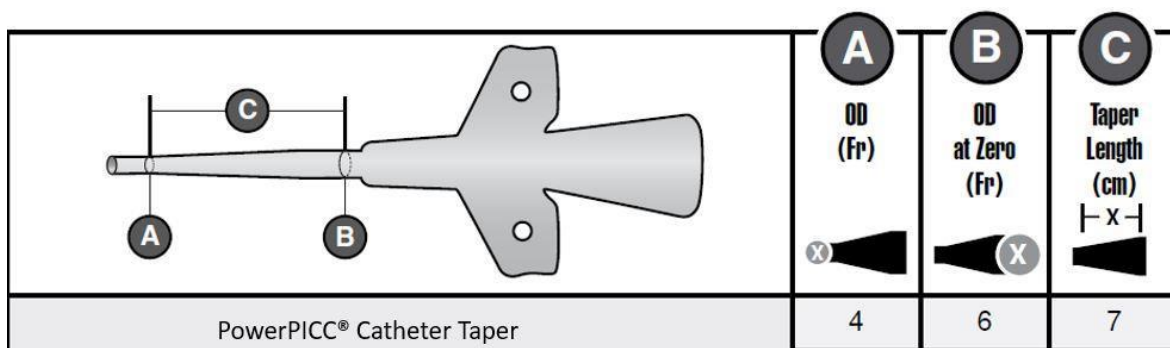
BD PICCs have a reverse taper which increases in diameter near the 0 marking on the device.

- Fully inserting the PICC device into the patient, as close as possible to the zero mark (position B in Figure 2), including the kink-resistant, reverse tapered region at the insertion site, is associated with lower leakage rates. To determine corresponding compression style size see figure 2, which shows that for the 4 Fr PICC, the size will be between 4 to 6 Fr, depending on the position of the securement device relative to the taper.

Figure 2: Image of the PowerPICC Taper Region

- BD strongly recommends the use of adhesive backed securement systems (e.g. Statlock) instead of 'compression style' securement systems.
- Securement systems should be appropriately sized to accommodate the increase in diameter of the catheter in the taper region.

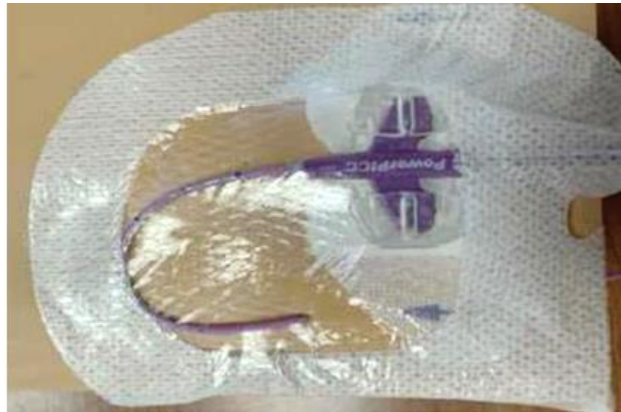
- Please note, using the J-loop technique when placing or dressing the catheter prevents insertion to the 0 mark and the use of this kink-resistant, reverse tapered region at the insertion site. See Figure 3 for an image of the J-loop. Where possible, refrain from using this technique.

Figure 3: Image of the J-loop
