## **URGENT Field Safety Notice**

### **Potential Loss of Electrical Grounding - IntelliVue Patient Monitor Power Supply**

**Reference:** CR # 2024-CC-HPM-030, Potential Loss of Electrical Grounding - IntelliVue Patient Monitor Power Supply

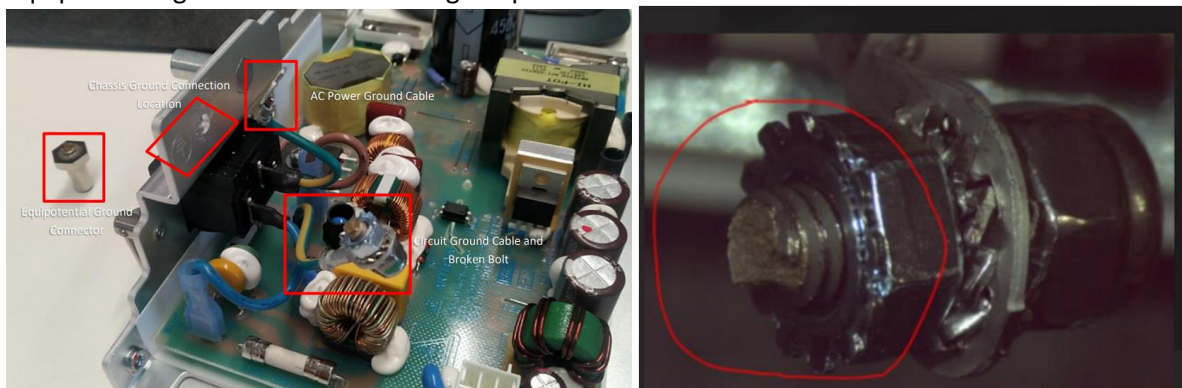
Electrical grounding is crucial to ensure that hospital patient monitoring equipment is safe, reliable, and in compliance with industry standards. Grounding provides a path for electrical current to return to the ground during faults, thereby minimizing risk of electric shock and protecting equipment from damage. It also controls leakage currents and dissipates static electricity that could pass through a patient's body or impair device function. Additionally, grounding helps to reduce electromagnetic interference (EMI), ensuring accurate readings of patient vitals and reduction of interference with other electrical equipment in the healthcare environment. During a production process, Philips became aware of one IntelliVue power supply with a broken ground bolt upon disconnection of the ground cable from the equipotential ground connector. Image depicted below.

**Figure 1. Power Supply Chassis and Circuit with Disconnected Ground Wires and Broken Ground Bolt**

Loss of electrical grounding may negatively affect the device's electromagnetic immunity and emission. Degraded electromagnetic immunity can cause the monitor to generate unreadable or unusable waveforms, potentially leading to incorrect/delayed patient treatment. Excessive or unintended electromagnetic emissions can also negatively impact the function of equipment in the vicinity of the patient monitor, potentially leading to delayed procedure. Although unlikely, these scenarios could potentially result in patient harm.

- Please check if the equipotential connector is broken off (refer to Figure 1). If yes, remove the device from use.
- Pass this notice to all those who need to be aware within your organization or to any organization where affected devices have been potentially transferred.
- Please complete and return the response form at the end of this letter to Philips promptly upon receipt of this notice and no later than 30 days.

A Philips representative will contact you to schedule a visit from a Philips Field Service Engineer who will replace the power supply.
