**URGENT Field Safety Notice**

Trilogy Evo, Trilogy Evo O2, Trilogy EV300  
Flow Sensor Nebulized Aerosol Deposition

**Reference:** Flow Sensor Nebulized Aerosol Deposition  
Trilogy Evo, Trilogy Evo O2, and Trilogy EV300  
2024-CC-SRC-013

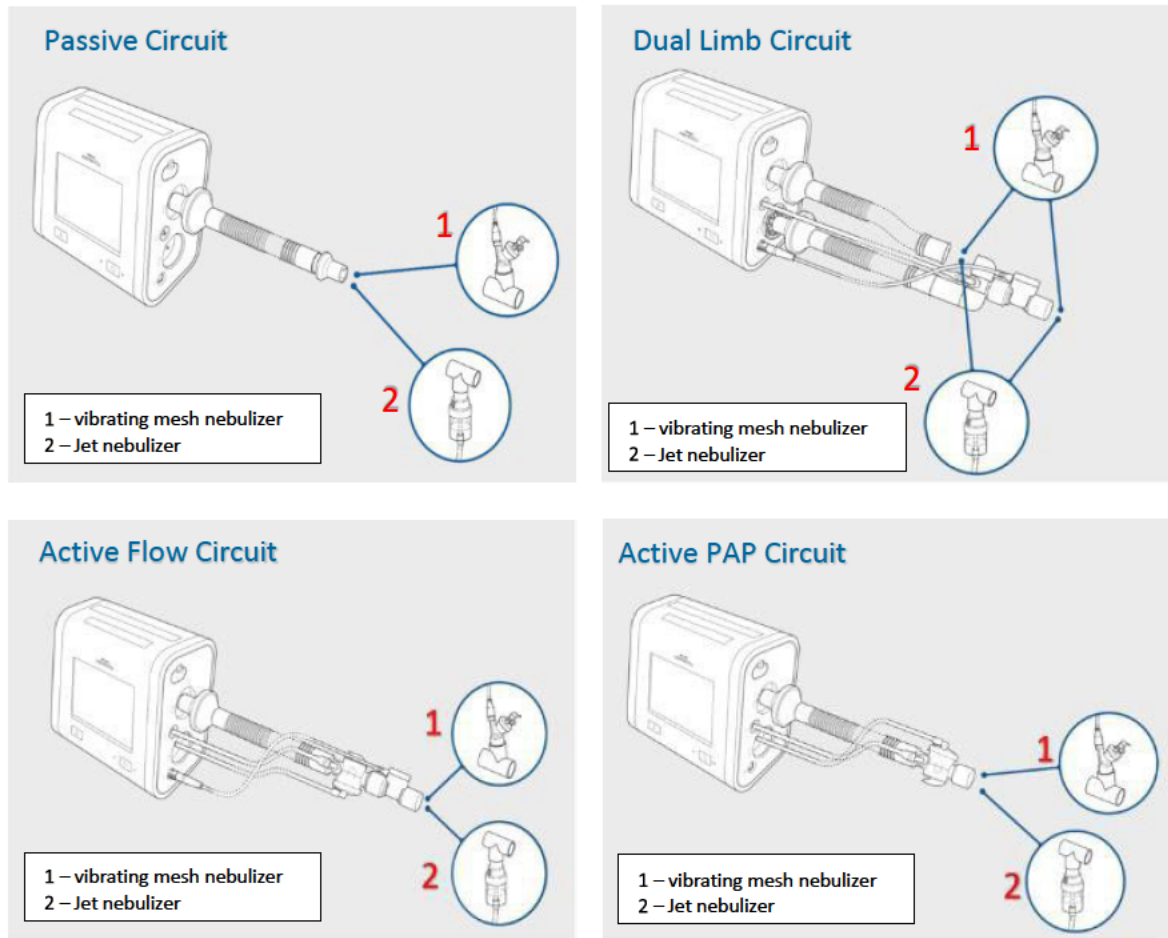
**Figure 1: Acceptable In-Line Nebulizer Placement.**

- When the in-line nebulizer is used with passive circuits for tidal volumes greater than or equal to 700 mL, or
- When the in-line nebulizer is placed at the dry side of the heated humidifier, or
- When the in-line nebulizer is placed at the “inspiratory port (to patient)” (device outlet), or
- When the in-line nebulizer is placed in any location *other than* those identified in the images in Section 4

- If using in-line nebulizer treatments:
  - The circuit must be configured as pictured in the images in Figure 1 below
  - For prescriptions needing tidal volumes greater than 700 mL with a passive circuit, transition patient to alternate circuit (Active PAP, Active Flow, or Dual Limb).
