| Place/Date: **Basel, 09.01.2026**

| Reference: **Urgent Field Safety Notice**

URGENT: Field Safety Notice

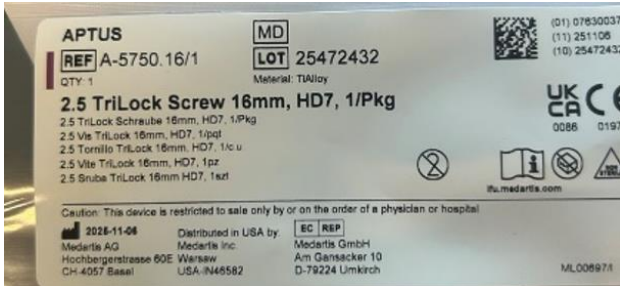
FSCA	FSCA 01-2026
Failure description	<p>A mix-up has been identified between the items “A-5750.16/1 2.5 TriLock Screw 16 mm, HD7, 1/Pkg” and “A-5850.16/1 2.8 TriLock Screw 16 mm”. The packaging for A-5850.16/1 contains an A-5750.16/1 2.5 TriLock Screw 16 mm, HD7, 1/Pkg, and conversely, the packaging for A-5750.16/1 contains an A-5850.16/1 2.8 TriLock Screw 16 mm.</p> <p>A picture of the label and screw A 5750.16/1 can be found here:</p> <div style="display: flex; justify-content: space-around; align-items: center;">

</div>
Results of the Risk Assessment	<p>The use of a 2.8 mm diameter screw, as opposed to a 2.5 mm diameter screw that can be locked in the corresponding plate, may increase the risk of intra-operative bone splitting, since greater force is required during drilling into the bone.</p> <p>The use of a 2.5 mm diameter screw, as opposed to a 2.8 mm diameter screw in the patient, may lead to prolonged procedure or healing phase, or health deterioration which leads in worst case to secondary loss of reduction.</p> <p>This risk is not acceptable for the user and/or patient.</p>

Corrective Action From Medartis	<ul style="list-style-type: none"> Field Safety Corrective Action (FSCA): Recall by the legal manufacturer Medartis AG Stock hold at headquarter and subsidiaries
Medartis Contact Person	<p>Ms. Claudia Zurbuchen-De Santis Tel: +41 61 633 37 23 E-Mail: complaints@medartis.com Medartis AG Hochbergerstrasse 60E 4057 Basel Switzerland</p>
Actions from Medartis	<ul style="list-style-type: none"> Field Safety Corrective Action (FSCA): Partial recall by the legal manufacturer Medartis AG Reporting to national competent authorities Inform all affected customers Internal investigation for root cause
Actions for affected Customers	<p><u>Actions for A-5750.16/1:</u></p> <p>Scenario A: Article packaged</p> <ol style="list-style-type: none"> 1. Identify the article of the affected batch in your warehouse 2. Place it in quarantine 3. Dispose of the item or return it to Medartis 4. Fill out this form and return it to Medartis (see chapter “2. Customer Reply”) <p>Scenario B: Article set in container</p> <ol style="list-style-type: none"> 1. Identify the article of the affected batch in your container 2. Check all screws in the screw module of size 2.5 mm for their outer diameter using
