FSN Ref: MRBR- MRBR-26H022

FSCA Ref: MRBR-26H021

Urgent Field Safety Notice
Digital Angiography System Trinias

Urgent Field Safety Notice (FSN)
Digital Angiography System Trinias
Risk addressed by FSN

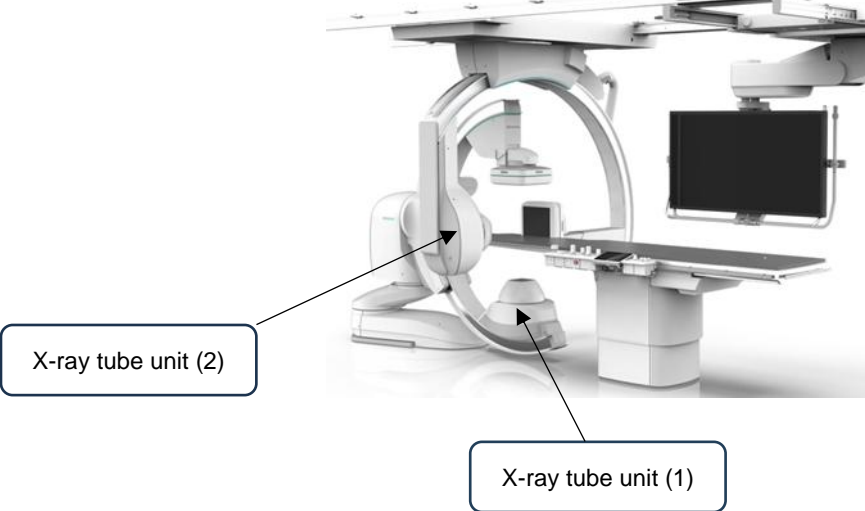
2 Reason for Field Safety Corrective Action (FSCA)*	
2	1. Description of the product problem*
.	In the biplane type (refer the figure below) of the Digital Angiographic System Trinias, when a specific operation is performed, a problem occurs rarely in which X-rays are emitted by the X-ray tube unit (2) even though the X-ray tube unit (1) is selected.

2	<p>2. Hazard giving rise to the FSCA*</p> <ul style="list-style-type: none"> For the following reasons, the severity level is "3" of "serious". <ul style="list-style-type: none"> The X-ray image is correctly collected even on the side of the unintended radiation plane, and the user can easily notice it and consider the increase of the dose in the treatment. In the next radiography, the unnecessary exposure is not caused by selecting the radiography protocol again, and the device can be used without any problem. The increase of the exposure dose is not large, and it is not at the level of "temporary injury or failure that does not require medical or surgical intervention." However, the risk of harm to the patient cannot be denied if the user feels uneasy about this failure and stops the examination and treatment.
2	<p>3. Probability of problem arising</p> <ul style="list-style-type: none"> The number of shipments of the Trinias biplane system is approximately 100 units. 12 years have passed since the release of this device, and assuming an average of 6 years of use, the number of radiographs so far is approximately 10 times/clinical x 5 cases x 200 days x 6 years x 100 units = 6 million times. Considering the past record of 2 occurrences, the probability of occurrence per 1 patient is considered to be 6 million times/10 times/2 times = 1 in 300,000 cases. Therefore, it falls within the range of "1/100, 000 (10⁻⁵) or Less to Over 1/1, 000, 000 (10⁻⁶)". Therefore, the possibility of the occurrence of harm due to unnecessary patient exposure was set as "1" in "Unlikely". In addition, based on the discussion at the Safety Committee, we examined the possibility that the user might feel uneasy about this event and interrupt the test. There have been no cases in which the test was interrupted, and especially since fluoroscopy works normally, it is unlikely that the test would be interrupted in a dangerous situation, which is lower than the above probability. Therefore, the possibility that a problematic event occurs in one patient and the test is interrupted, and then harm occurs, was set as "1" in "Unlikely".

2	It was found that this issue occurs at a low probability when both “switching the X-ray tube unit used for radiography” and “switching radiography method” are set as reservation operations for the next procedure during fluoroscopy, fluoroscopy is terminated, and radiography is performed. Note that this issue does not occur by “switching the X-ray tube unit used for radiography” and “switching radiography method” in a state where fluoroscopy is not performed, or by only one operation of either the “switching the X-ray tube unit used for radiography” or the “switching radiography method” under fluoroscopy.
2	7. Other information relevant to FSCA
	—

3. Type of Action to mitigate the risk*			
3.	<p>1. Action To Be Taken by the User*</p> <p> <input checked="" type="checkbox"/> Identify Device <input type="checkbox"/> Quarantine Device <input type="checkbox"/> Return Device <input type="checkbox"/> Destroy Device <input type="checkbox"/> On-site device modification/inspection <input type="checkbox"/> Follow patient management recommendations <input type="checkbox"/> Take note of amendment/reinforcement of Instructions For Use (IFU) <input checked="" type="checkbox"/> Other <input type="checkbox"/> None </p> <p>• This issue occurs when switching from a bi-plane to a single-plane during fluoroscopy. Until countermeasures are completed, Please avoid this issue by switching planes after fluoroscopy.</p>

4. Is customer Reply Required? * (If yes, form attached specifying deadline for return)	Yes		
3.	<p>5. Action Being Taken by the Manufacturer</p> <p> <input type="checkbox"/> Product Removal <input checked="" type="checkbox"/> On-site device modification/inspection <input type="checkbox"/> Software upgrade <input type="checkbox"/> IFU or labelling change <input type="checkbox"/> Other <input type="checkbox"/> None </p> <p>We will update the software for the target device so that the X-ray tube unit can be switched correctly.</p>
