FSN Ref: 2025-FSN-0000124

Date: 2026-01-28

URGENT Field Safety Notice
Risk of Differential Pressure (dP) Sensor drift in Impella RP Devices

1.	4. Device Model/Catalogue/part number(s)* 0046-0011
1.	5. Software version Not relevant
1.	6. Affected serial or lot number range All Impella RP devices

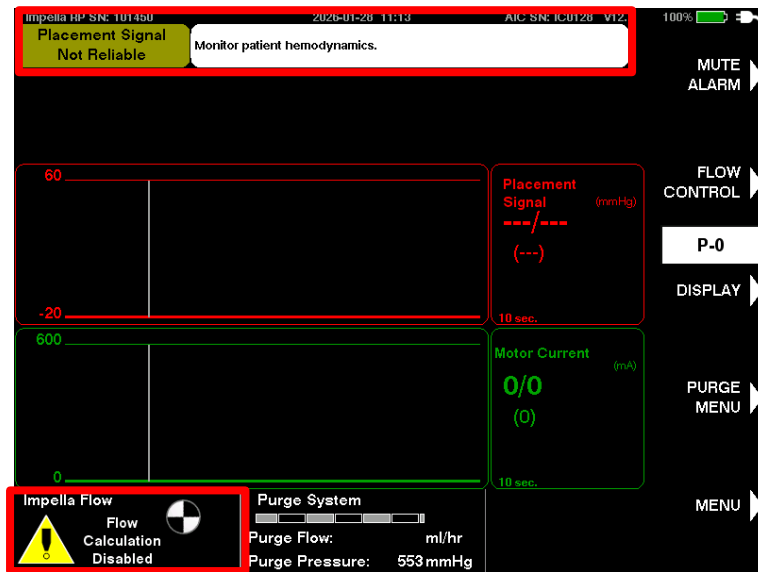
Figure 1: Example AIC screen during PSNR due to the dP sensor

2. Reason for Field Safety Corrective Action (FSCA)*	
2.	1. Description of the product problem* Abiomed has identified a risk of Differential Pressure (dP) sensor drift in Impella RP pumps, which may cause inaccurate flow readings and Placement Signal. The dP sensor measures the pressure difference between the inlet and outlet of the RP Impella pump which serves as an input for the pump metrics listed above. There is no way to confirm error in the flow calculation directly from the pump signals in these situations. When the dP sensor signal exceeds the operating range for the sensor, the flow calculation will disable and a "Placement Signal Not Reliable" (PSNR) alarm will be displayed on the AIC, as shown in Figure 1. Please note that the PSNR alarm may not be triggered in all instances of dP sensor drift. The dP sensor does not affect the pump's ability to provide hemodynamic support. Pump flow is driven by the motor current and does not rely on the pressure sensor.

The dP sensor is only present on Impella RP devices and not on Impella 5.5 and Impella CP devices.

As per the AIC Alarm text, clinicians should continue to: monitor patient hemodynamics with approved diagnostic devices, verify Impella positioning with imaging. Additionally, please refer to the P-level flow rates listed in the Instructions for Use (IFUs), as shown in Figure 2 in this letter. These values reflect the flow rate range of the pump on defined pressure gradients under controlled conditions; actual pump flow depends on preload, afterload, and can vary due to suction, incorrect positioning, or presence of thrombus in the inlet.

- continue to monitor patient hemodynamics with approved diagnostic devices and continue to verify Impella positioning with imaging before clinical interventions.
- refer to the P-level flow rates listed in the Instructions for Use (IFUs), as shown in Figure 2, and rely on these values rather than the AIC display. The values in the IFU reflect the flow rate range of the pump on defined pressure gradients under controlled conditions. Clinicians should be aware that actual pump flow depends on preload, afterload, and can vary due to suction, incorrect positioning, or presence of thrombus in the inlet.
