Date: 27-Jun-2025

Urgent Field Safety Notice
3mensio Workstation (Vascular – Fenestrated)
Version (10.6, 10.6 SP1, 10.6 SP2, 10.6 SP3, 10.6 SP4, 10.7, 10.7 SP1)

The purpose of this letter is to advise you that Pie Medical Imaging is issuing an urgent Field Safety Notice regarding the clock position visualization in the fenestration diagram in 3mensio Workstation 10.6 (Vascular – Fenestrated layout) or 3mensio Workstation 10.7 (Vascular – Fenestrated layout).

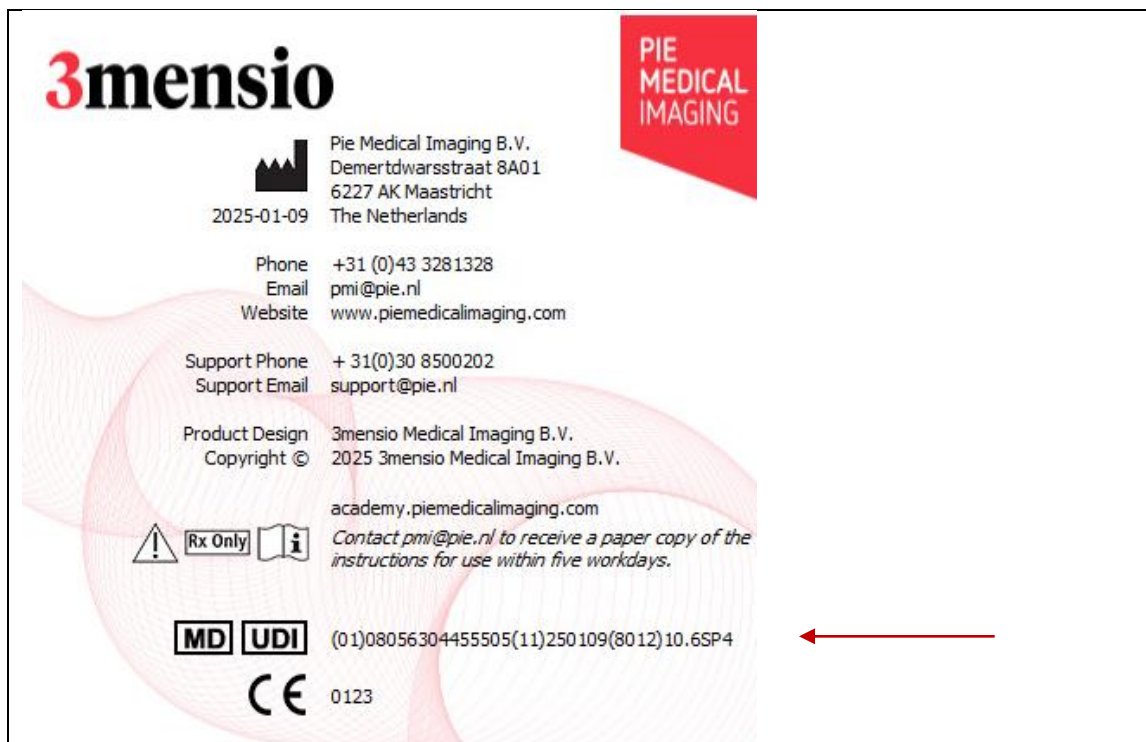
The UDI can be found in the About Box, which can be found as follows:

1. Open application
2. Click on the '?' in the top left corner
3. Click on 'About'

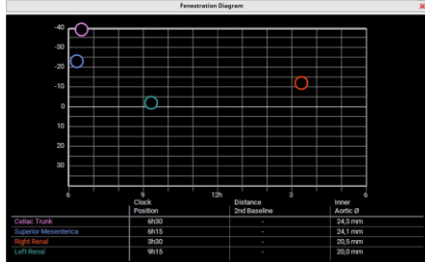
Observed behaviour: In the fenestration diagram only the adjusted clock measurement is updated to the new 12h position. The other clock measurements are not updated relative to the new 12h position

Opening a fenestrated analysis with clock measurements	Changing 12h position of a single clock measurement → Only the adjusted clock measurements is updated in the fenestration diagram.

Impact: The hazard exists that the clock positions are not correct in the report causing fenestrations on a stent graft at an incorrect position. This could potentially be harmful for the patient since this could potentially lead to permanent tissue damage. If FSN advice is followed there is no residual risk.

In case you open a session state with saved clock measurements created in **3mensio Workstation 10.6** and there is a need to adjust the **12h position** for the clock positions, make sure to update **all** individual clock measurements in the perpendicular plane by the following steps:

1. Click on the clock position.
2. Update the 12h pointer of the clock in the perpendicular viewport.
3. Perform step 1 & 2 for all clock measurements in the analysis.
