URGENT Field Safety Notice

“Purge System Blocked” alarm delay with AIC Old Software version

For Attention of*: Users of Automated Impella Controller (AIC) with software version below 10.1 (Specifically versions 8.2.2 and 8.5) in conjunction with Impella 5.5 first generation (Code 0550-0002)

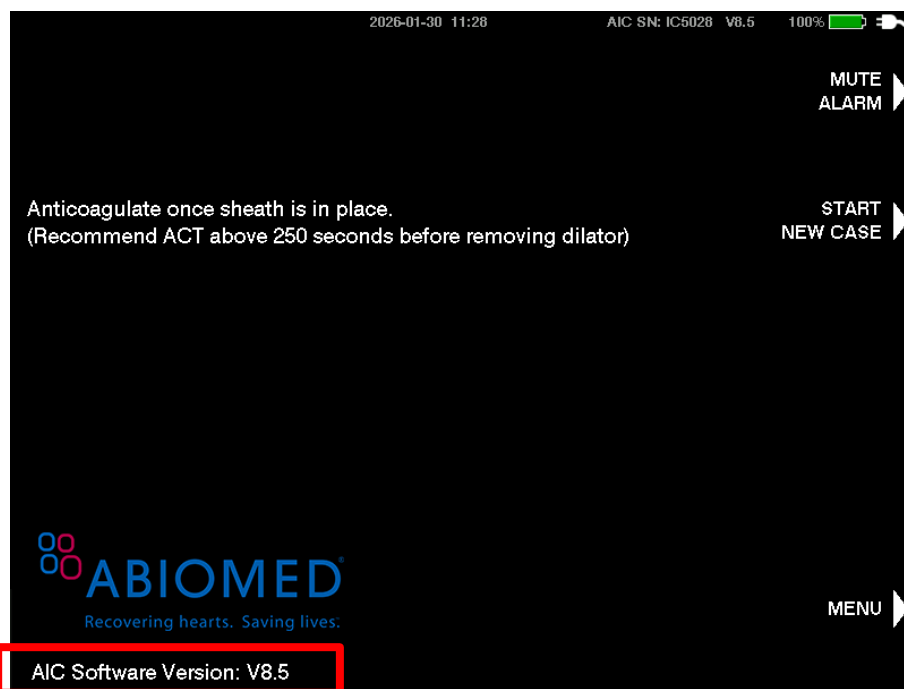
Figure 1: AIC Software Identification on Example Startup Screen

- Abiomed recommends that you do not use the AIC with an Impella 5.5 first generation (product code 0550-002) unless AIC software is updated to V10.1 or above.
- AIC software version can be identified in the lower left corner of the initial AIC display screen, see Figure 1 below for example.

- Where required, please contact Abiomed at RA-ABM-EUFieldServic@ITS.JNJ.com to schedule your software update.
- Review, complete all fields, sign, and return the attached Customer Reply Form to DL-EUFSCA@its.jnj.com.
- Forward this notice to anyone in your facility that needs to be informed (i.e., those who manage, transport, store, stock, or use the subject products).
- If any of the subject products have been forwarded to another facility, contact that facility and provide them with this notice.
- Post a copy of this notice in a visible area for awareness.
