Siemens Shenzhen Magnetic Resonance Ltd., SHS DI MR QT, Siemens MRI Center,  
Gaoxin C. Ave., 2nd Hi-Tech Industrial Park, 518057 Shenzhen

**Customer Safety Advisory Notice MR041/25/S**

### **Inspection of Magnet Venting System**

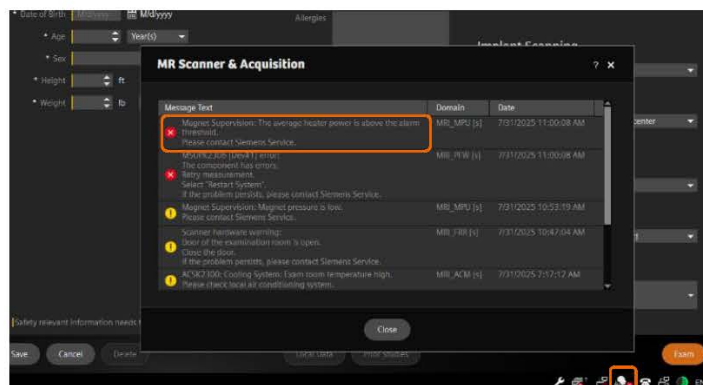
- If the error message shown in Error! Reference source not found. appears on your host computer, **do not reboot the system**. Please call your local Siemens Healthineers service organization.

**Figure 1 - Error message:** "Magnet Supervision: The average heater power is above the alarm threshold. Please contact Siemens Healthineers Service."
