Urgent safety information

Jena, 29.04.2024

Re: O-ring replacement required for MultiCut Blade 400 and MultiCut Blade 350

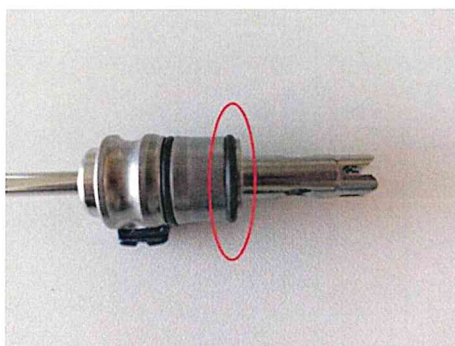
Figure 1

Since the beginning of 2024, we have received various feedback that the suction power of the MultiCut Blades can decrease during use.

A vacuum is required for suction in the blades. For this purpose, the blades must be sealed in the handpiece. Sealing is achieved by using an O-ring (Fig. 1). This seal is not sufficient under certain circumstances. This is due to the mechanical load on the blade caused by the simultaneous use of an endoscope. This acts selectively on the blade and can cause a mechanical effect. In these cases, the vacuum drops and the suction power decreases.

The O-ring is located on the part of the blade that is attached to the handpiece:

The O-ring responsible for the seal (2 mm) must be replaced with another (2.2 mm). This can be done very easily by the user or distributor, a technician is not required. Detailed instructions can be found below.
