### **Urgent Field Safety Notice for SPECTRALIS® Users**

**Affected devices:** SPECTRALIS® with Flex Module

**Reference ID:** TFID-10785

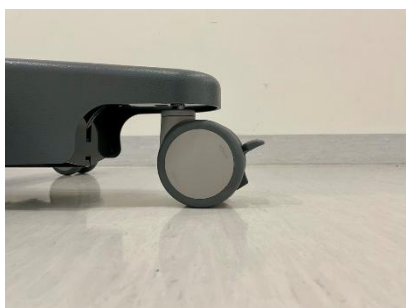
- If a wheel is **upright and straight**, it is correctly positioned (see Figure 1) .
- If a wheel is **tilted or leaning**, it is not correctly positioned (see Figure 2)

*Figure 2 Tightened wheel*

Correctly positioned

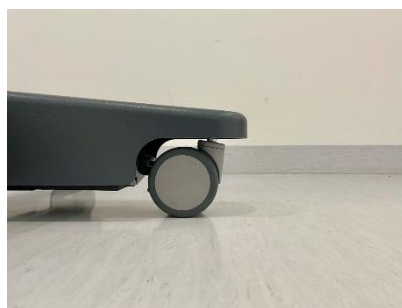
*Figure 2 Loose wheel*  
⚠ Do not move stand.

Incorrectly positioned

⚠ If the wheels are tilted or leaning, do not move the stand anymore until the problem has been corrected!

In any case, please schedule a service appointment with your Heidelberg Engineering service partner as soon as possible so that the castor fastenings can be inspected and, if necessary, corrected.
