Urgent Field Safety Notice
Plus Initial Drill 103.170 lot LNWT8

Urgent Field Safety Notice **Plus Initial Drill 103.170 lot LNWT8**

Missing depth Markings

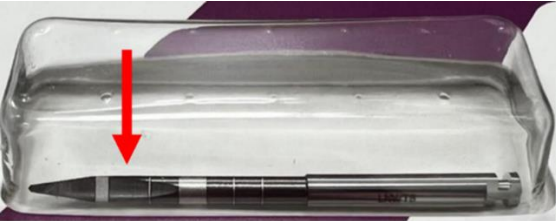
<p>103.170 – Batch LNWT8 Non-conforming Product</p> </div> <div style="text-align: center;">

2. Reason for Field Safety Corrective Action (FSCA)*	
2.	1. Description of the product problem*
	The 103.170 Plus Initial Drill was produced without the laser engraving of 7mm, as shown in section 1.6 This is an isolation issue affecting the above-listed article lot only.
2.	2. Hazard giving rise to the FSCA*
	The absence of one of the laser-engraved markings on the active portion of the Drill may impair the measurement of the bone milling, since this is crucial for the professional when preparing the

3. Type of Action to mitigate the risk*	
3.	<p>1. Action To Be Taken by the User*</p> <p> <input checked="" type="checkbox"/> Identify Device <input checked="" type="checkbox"/> Quarantine Device <input checked="" type="checkbox"/> Return Device <input type="checkbox"/> Destroy Device </p> <p> <input type="checkbox"/> On-site device modification / inspection </p> <p> <input type="checkbox"/> Follow patient management recommendations </p> <p> <input type="checkbox"/> Take note of amendment / reinforcement of Instructions For Use (IFU) </p> <p> <input checked="" type="checkbox"/> Other <input type="checkbox"/> None </p> <ol style="list-style-type: none"> Search your inventory and/or surgical kits in use for units of item 103.170 – PLUS INITIAL DRILL - Lot LNWT8. The lot is identified on the part, use Figure 2 below as a support for batch identification. Identify and separate all units of this lot, whether open or closed. If the product was used and no complications or problems were identified, or the patient did not present symptoms, there is no need for any additional action with the patient. Identified product is to be returned to address listed on FSN <ul style="list-style-type: none"> Send the product(s) to the us. ATTENTION! When sending the product, if any unit is open, place it in surgical paper and decontaminate it before shipping. If the product is not found in your stock, indicate this on the Customer Confirmation Form. In all cases, complete, sign and return the Customer Confirmation Form for Field Action.

<p>Figure 1 - Identify the initial drill without the 7mm marking and confirm the LNWT8 batch on the</p>

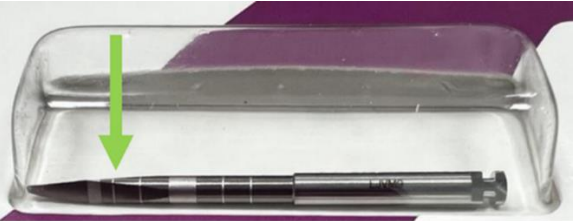
<p>103.170 – Example Conform Product</p> </div> </div>
