URGENT - FIELD SAFETY NOTICE - RECALL

Extended Tip Applicator (XTA) (ref. 205108 and 205115)

Integra LifeSciences is voluntarily issuing this Field Safety Notice for the recall of **Extended Tip Applicator (XTA)** listed in Table 1.

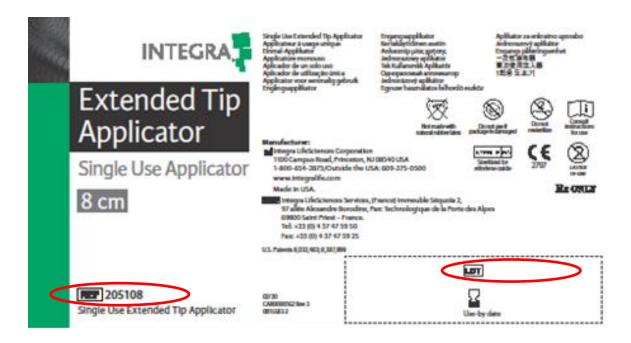
Appendix 2: Product Label sample

Reference 205108. Use Red Circle below to Identify Lot Number
