Urgent Field Safety Notice

Product Name: POLYCENTRIC 4 BAR MANUAL LOCKING KNEE

Product Code: 2-01-S400L

Device Type: Polycentric 4 Bar Knee Joint

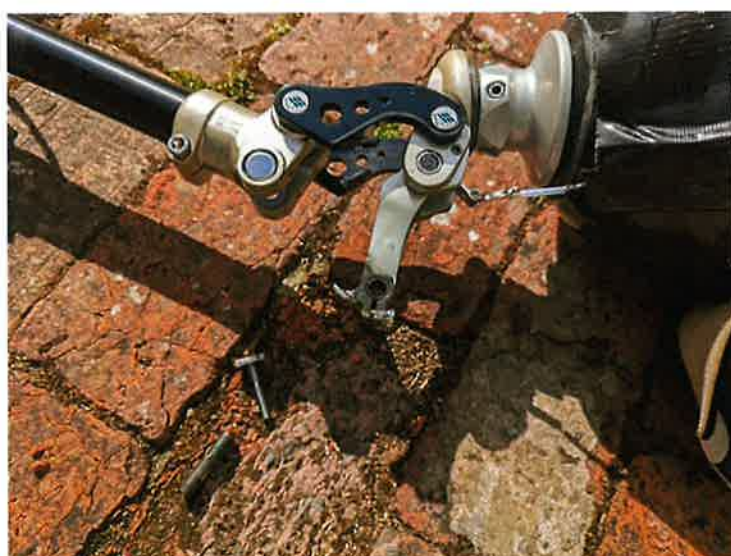
This FSN is to inform you that a UK clinic reported a 2-01-S400L knee joint failure on May 29, 2025. The Serial No. is 11706, Lot No. 2437. We received the Yellow Card notification on June 11, 2025.

As the practitioner described, the patient was walking in garden, suddenly the bolt cover fell off allowing central bolt to come out of knee joint and knee collapsed in half as a result. See the below photo:

1. Although the cause of failure is still unknown at this moment, for a precautionary measure, we would suggest the practitioners to have safety check on these 6 patients who have the Lot no. 2437 knee joints installed into their prostheses.
2. When the practitioner performs the checking, please make sure the two set screws are still intact. No need to make any adjustment.

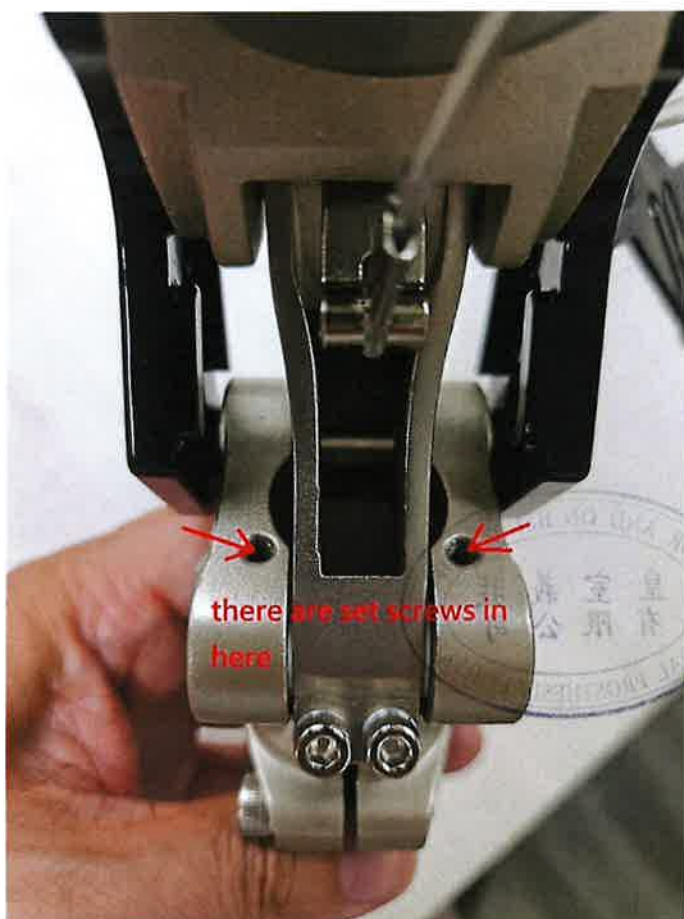
1. The practitioner described bolt cover falling off allowing central bolt to come out of knee joint is NOT the real cause. The bolt cover is for cosmetic purpose. The bolt cover has no function to keep the central bolt intact.
2. The critical component to keep the central bolt in position is the two set screws (see below photo)

3. When these two set screws get loose or removed, then the central bolt will come out.
4. But these two set screws are not mentioned in the IFU. They are NOT adjustable components. No practitioner should adjust these two set screws at any reason.
5. Therefore, we still need to physical inspect the broken knee joint to find out if the set screws are still intact or gone missing.
