**URGENT FIELD SAFETY NOTICE – Product Recall**

SPII Model Lubinus, Hip Prosthesis Stem XL Neck, cemented, L= 150 mm, left L3, large, CCD 126°, CoCrMo, anatomical, Taper 12/14 [Article Ref 127-767/26]

**FSN Ref.: R-2026-03#02**  
**23.03.2026**

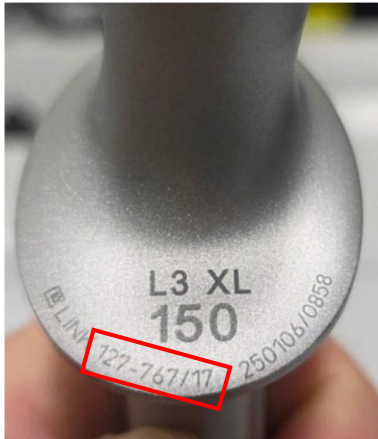
**Incorrect**

CCD-Angle: 117°  
Article Ref: 127-767/17

**Correct**

CCD-Angle: 126°  
Article Ref: 127-767/26

Figure 1: The device laser markings of the affected SPII Hip Stem 127-767/26 show the incorrect Article Ref and CCD-Angle.

Due to a complaint, it has come to our attention that the device laser markings of one production order of SPII Model Lubinus Hip Stems with the article Ref 127-767/26 show the incorrect Article Ref 127-767/17 and the wrong CCD-Angle 117°.

Should you have any of the affected product in your inventory, please send the products back to Waldemar Link GmbH & Co. KG.
