**FIELD SAFETY NOTICE – FSCA****Instructions for users on how to handle the affected product.**

SIGNUS implant:

Item number	Batch	Date of manufacture	Item description
PSL052043	LOT 857931-BC	01.11.2024	POSEIDON ST Endplate 20x43mm 5°

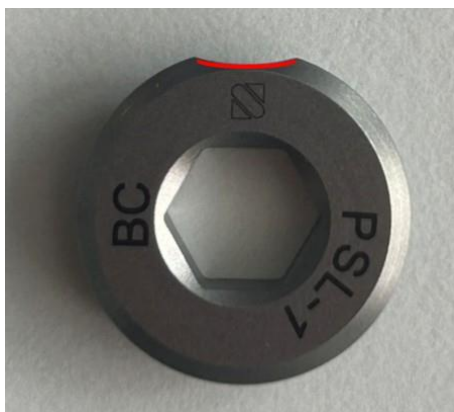
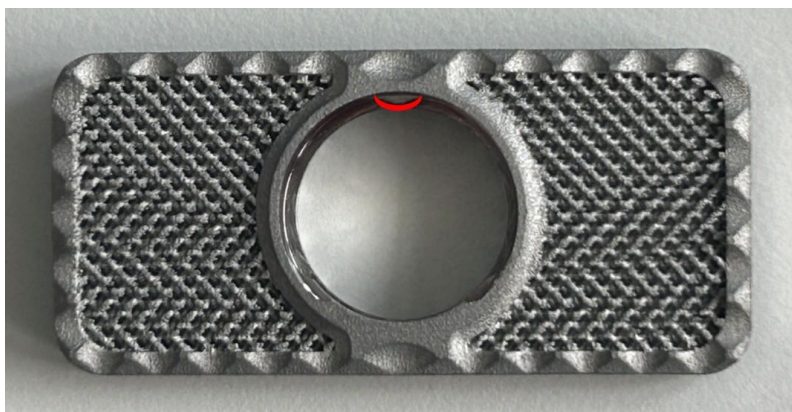
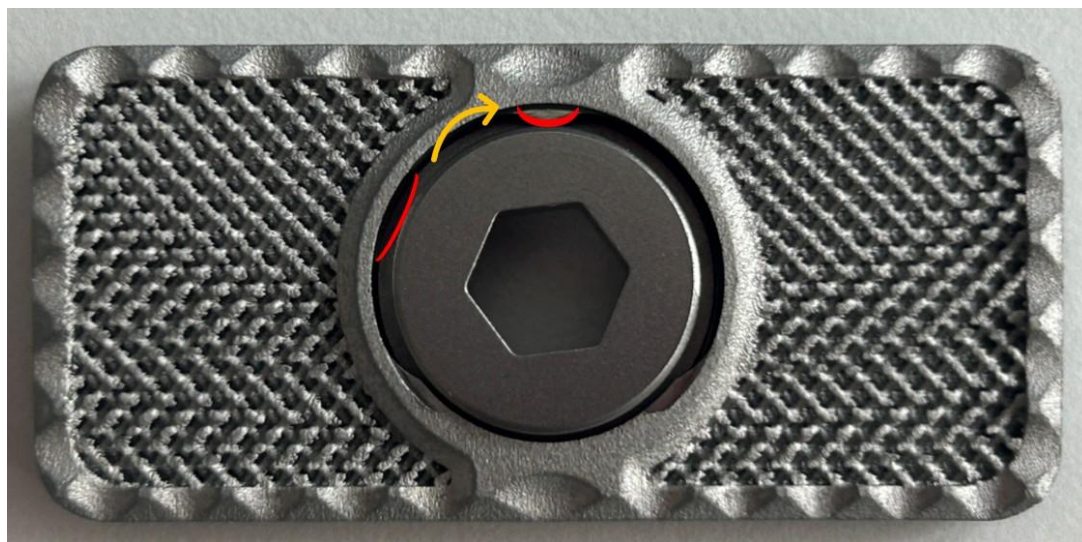
### 1. Remove the connecting screw from the endplate

Turn the connecting screw until the notch on the screw is aligned with the bulge on the plate. The connecting screw can be removed by tilting it sideways.

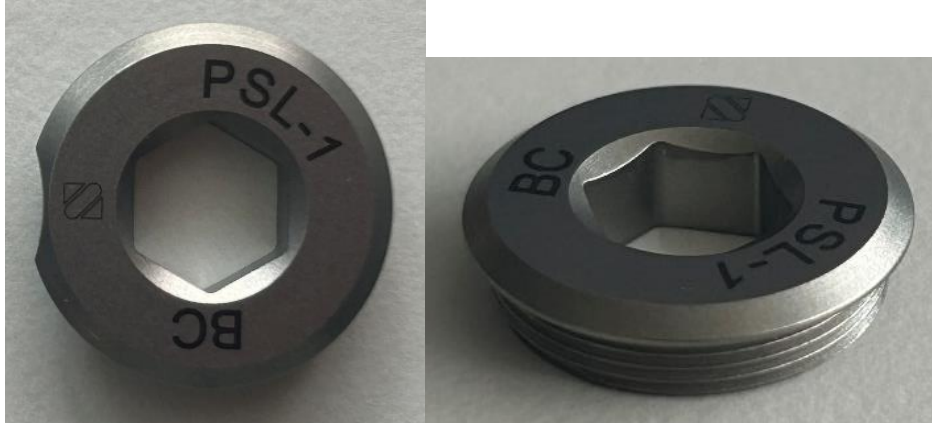
Connecting screw at the top:

Turn the connecting screw so that the labeling on the screw and the teeth on the endplate are at the top.

The connecting screw must be inserted into the endplate with the labeling facing upwards.

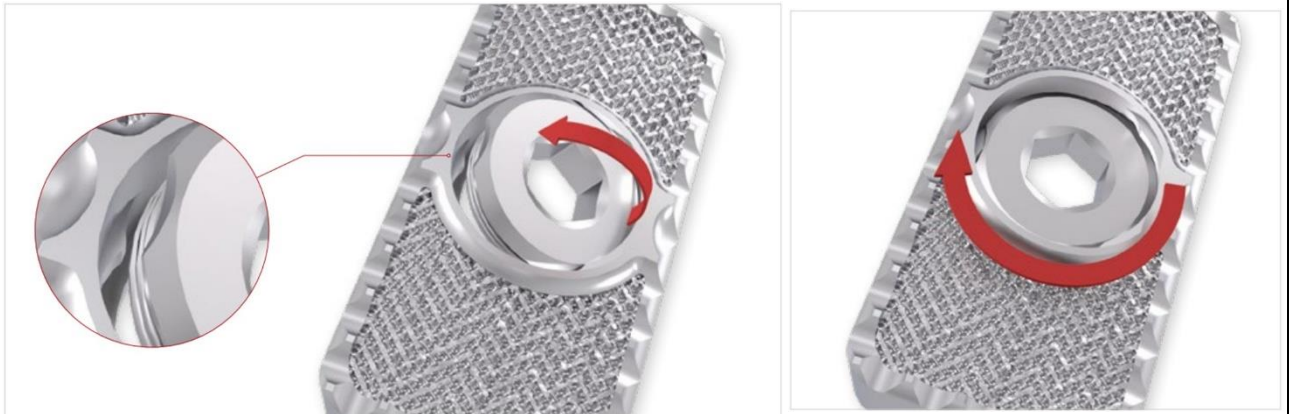
### 3. Insert the connecting screw

The connecting screw must be aligned so that the notch on the screw is in line with the bulge on the plate.

The screw is then inserted at an angle into the endplate and turned.

BEFORE correction	AFTER correction
Endplate teeth at top and connecting screw labeling <b>at bottom/not visible</b>	Endplate teeth at top and connecting screw labeling <b>at top/visible</b>
