## Urgent safety information

### for LUISA, TIVAN LS, Life One (LM150TD) ventilators

to urgent safety information (FSN-2024-01)  
for the LUISA ventilator (LM150TD)

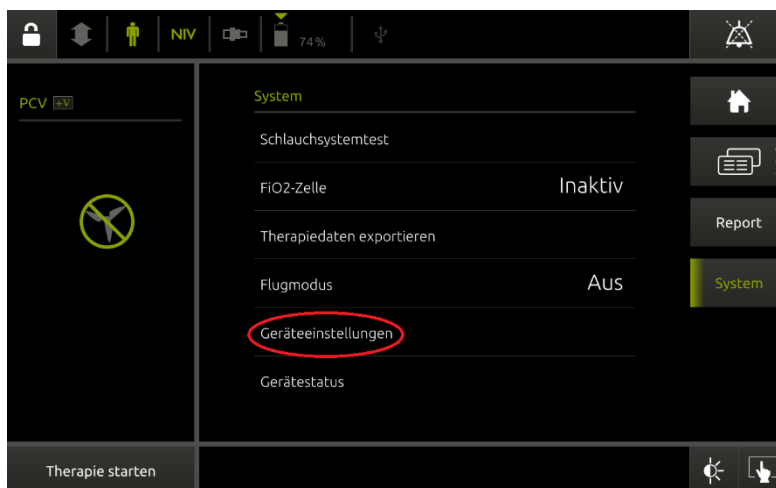
2. Then go to "device settings":

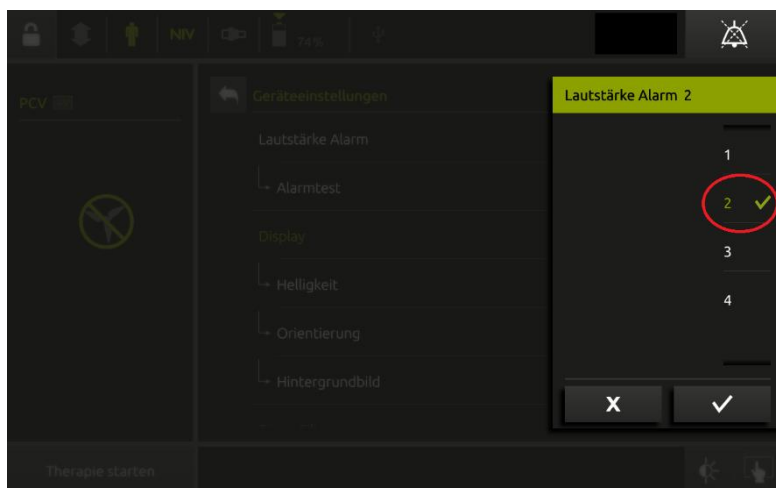
4. Select “Alarm volume 2” or higher and the corresponding alarm tone will be emitted once. Then press the confirm button. Now, you are guaranteed to have an acoustic alarm signal when the alarm goes off.

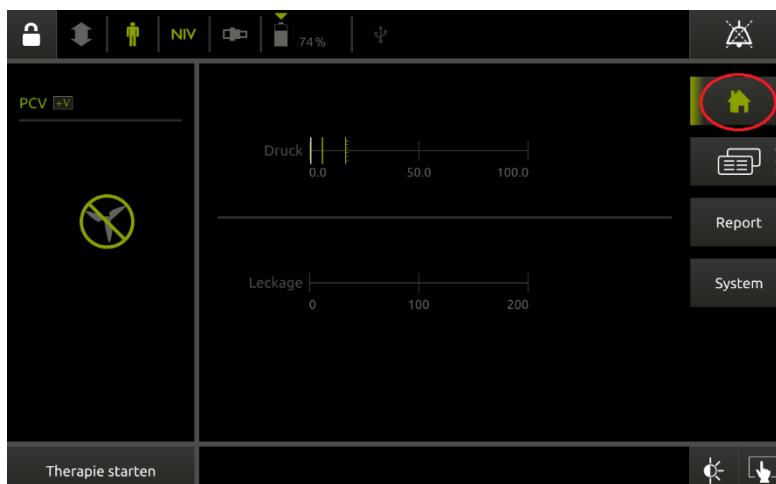
5. Press the home button to return to the main menu:
