For all users of mint Lesion™ versions from 3.8.6 up to and including 3.9.2

2024-01-10

Urgent Field Safety Notice

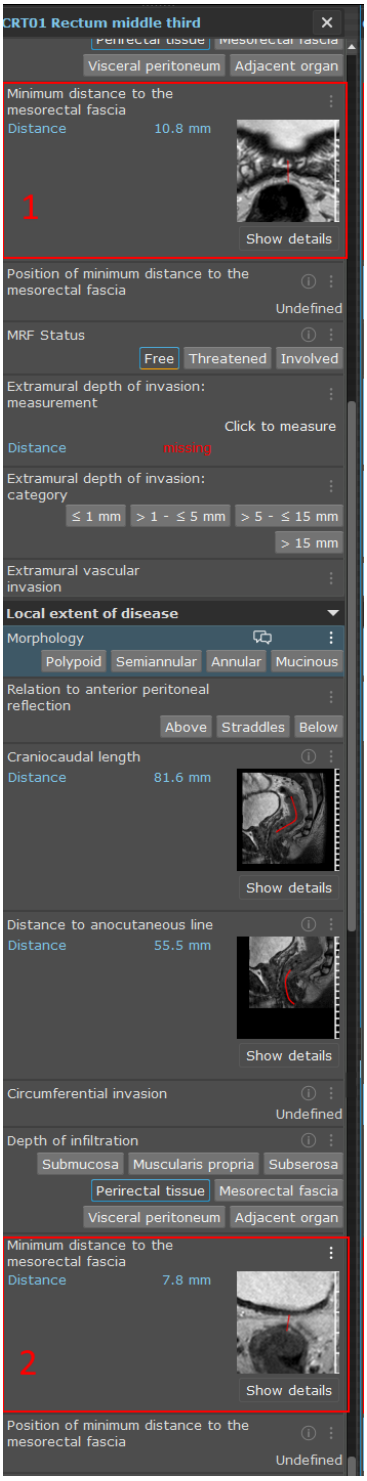
After switching to a different time-point, different case or different patient, the sidebar area in the read screen will erroneously still display the eCRF section from the original patient and time-point that contains the measurement question, including the measurement value and other answers that apply to the originally selected patient and time-point. The section that applies to the current patient and time-point is displayed, too. The user interface does not allow to identify which section belongs to the current patient/time-point and which section contains outdated information. Figure 1 shows this situation.

The measurement questions could be displayed either as missing or with values from other time-points or patients. Figure 1 shows an example: The measurement question "Minimum distance to the mesorectal fascia" is erroneously shown twice, once for the current assesment context (marked with **2**), once for a prior assessment context (marked with **1**) .

Figure 1: The measurement "Minimum distance to the mesorectal fascia" is displayed both for the current assessment context and erroneously additionally for a wrong assessment context

Please read this information carefully and assess whether you are using an affected product version and affected reading templates. If that is the case, the malfunction may occur in your system. Please be aware that the malfunction may occur. When assessing follow-up time-points (e.g., re-staging or response assessment follow-up), scroll through the sidebar to check if duplicate sections are shown. If a section is shown twice, please close and restart the application. This will remove the out-of-context section from the sidebar.

You can prevent this malfunction from occurring by restarting the application in between each assessment that is using one of the affected reading templates.
