**URGENT – FIELD SAFETY CORRECTIVE NOTICE****GETINGE 88-5 Washer disinfector  
Field Action 1303821 – CAPA 1287961**

Product Issue: A Getinge 88-5 washer-disinfector caught fire due to overheating of the heater element, caused by absent or incorrect calibration of the circulation pressure sensor.

Affected Product: Getinge 88-5 Washer disinfector (all units with electrical heating)  
Only those units identified in the below list of affected serial numbers for your market were identified to be affected.

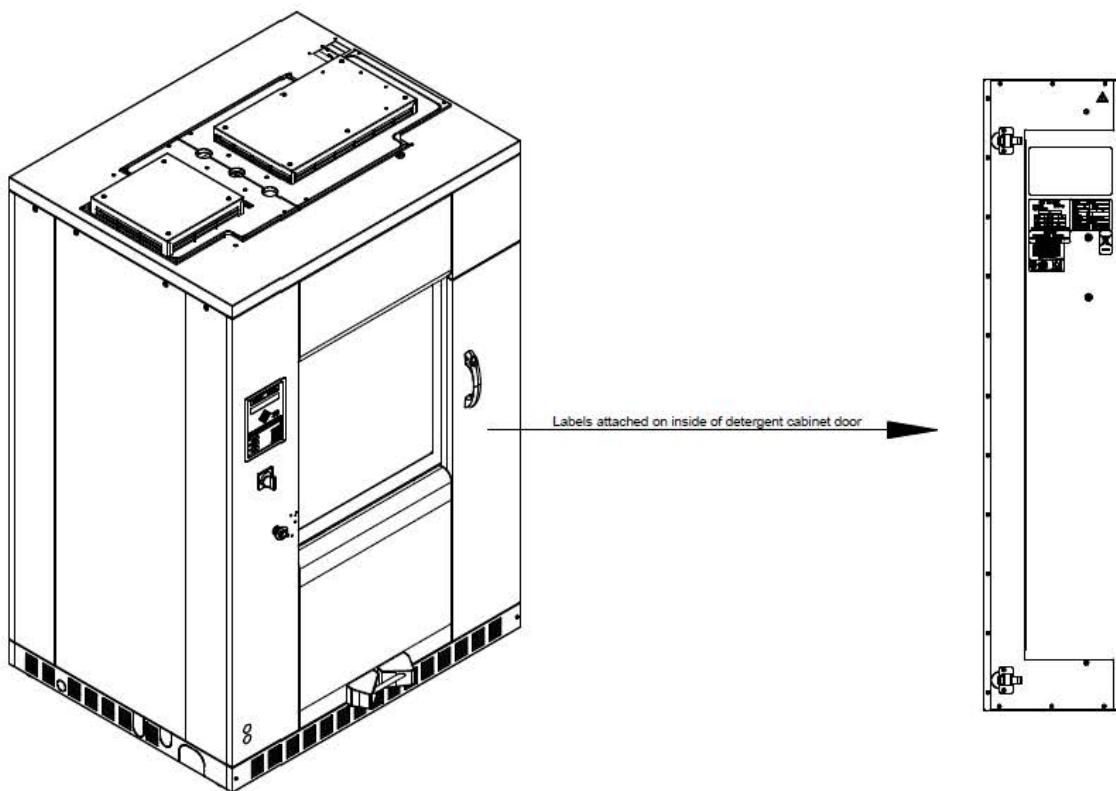
The serial number is located on the marking label attached to the machine. This label is placed on the inside of the detergent cabinet door, see picture below:

1. Check the serial number of your Getinge 88-5 Washer disinfecter. The serial number shall correspond with the serial number on the customer response form (Appendix 1).
