# URGENT NOTICE MEDICAL DEVICE RECALL

## Drive DeVilbiss Healthcare Car Charger Power Cord Accessory (provided with the iGo<sup>®</sup>2 Portable Oxygen Concentrator)

Isny, May 30th, 2025

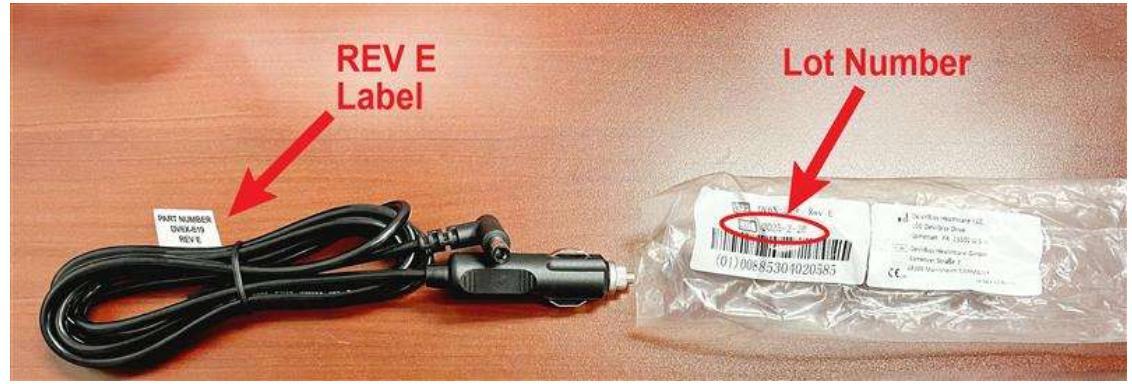
Figure 1: "Rev E" label and lot number placement

- 1. Identify any inventory in your possession using the following identifiers:
  - a. model DV6X-619 Rev E car charger cords of lot numbers 2023-01-01 through 2024-12-31 (see **Figure 1** below). <u>Not all Rev E cords are recalled</u>. Refer to step 1c below to confirm if the Rev E unit is recalled.

- 2. Destroy all affected car charger cords by cutting the cord with wire-cutters or unscrewing the cap and then discarding the car charger parts.
- To obtain replacement car charger cords, click on the Verification Code hyperlink, located on the first page of this notice directly below the address block, or go to <u>www.recallrtr.com/iGo2DME</u> and input the Verification Code. Using that code on the website, you will be able to:
  - a. Please confirm receipt of this recall and confirm the quantity of affected car charger cords in your possession (see **Table 1** on page 5 for the full range of affected lots and serial numbers)
  - b. Order replacement products; and
  - c. Fill out a web form to acknowledge receipt of and compliance with this recall.

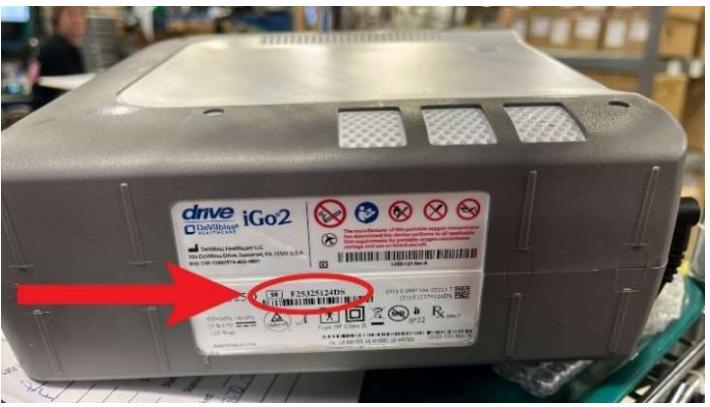
Figure 2: Serial number placement on iGo®2 POC Device

b. If the cord that was originally included with the iGo<sup>®</sup>2 POC unit is still with the POC, the affected cords can also be identified by the serial number on the iGo<sup>®</sup>2 POC unit (see Figure 2 below). The range of applicable serial numbers is provided in Table 1 on page 5.

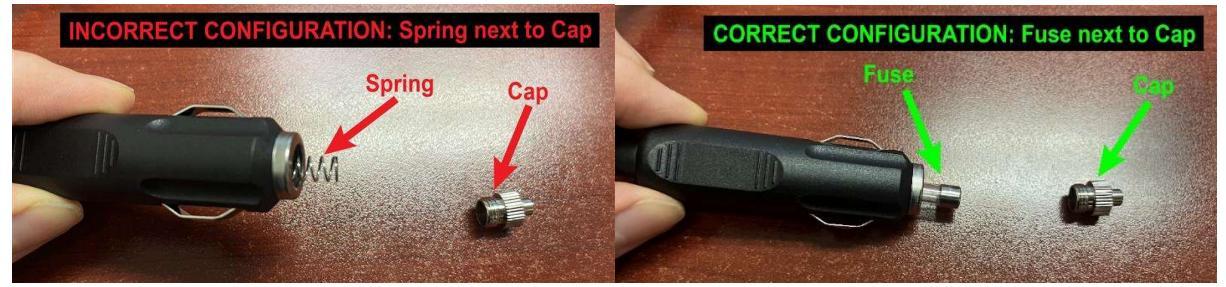
After receiving complaints related to overheating of the plug portion of the car charger cord, an investigation determined the root cause was an assembly error; specifically, the fuse and the retention spring were installed in the reverse positions. It was confirmed that during use, the adapter connection may become hot to the touch, and in some cases, cause deformation of the plastic housing. The manufacturing assembly error has now been corrected.

- c. If there is any doubt, or if you do not maintain the car charger cord with the original POC unit as part of your rental distribution process (i.e., used cords are stored and comingled in a box), inspection and confirmation of the condition of the car charger cord adapter can be easily performed by unscrewing the metal cap. (See **Figure 3** for spring and fuse position.)
  - *i. If it reveals the internal spring next to the cap*, this configuration *is being recalled.*
  - ii. *If it reveals the fuse next to the cap*, this configuration <u>is not recalled</u>. Note: For every product confirmed to be unaffected by this recall, we recommend that you mark the label as acceptable in some permanent manner to ensure future inspections are unnecessary after rental redistribution and return.

Figure 3: Inspecting the car charger cord adapter for spring or fuse position.
