Urgent Field Safety Notice (FSN)

Product Name: Digital Diagnostic Mobile X-ray System GM85

Title: Reinforcement of Moving Arm which holds the THU

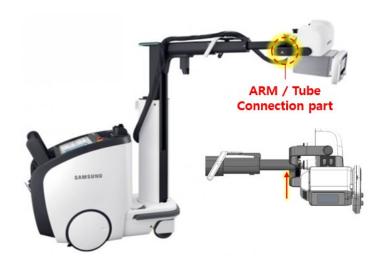
We have received a report regarding the loosening or breakage of bolts that connect the Tube Head Unit (THU) to the arm. An investigation determined that this may be caused by metal fatigue resulting from accumulated stress over a long period of use. If all connecting bolts were to fail, it could potentially cause the THU to detach from the arm, posing a risk of serious injury to a patient or user.

The four (4) M5 bolts that secure the Tube Head Unit to the end of the arm may loosen or fracture due to metal fatigue. This can lead to instability or wobbling of the arm. In a worst-case scenario where all bolts fail, the Tube Head Unit could detach.

Samsung Electronics will carry out the field safety corrective action for all affected systems produced between October 2016 to July 2018. The corrective action is to reinforce the arm with a high tensile bolt to eliminate the risk of the THU falling and preventing any potential risk of injury. Samsung service engineers will correct all affected systems free of charge and contact you to arrange for the correction.
