**To the Customers of the  
Dräger VentStar Resus Neo / VentStar Resuscitaire**

## Important safety notice!

### Possible leaks due to cracks

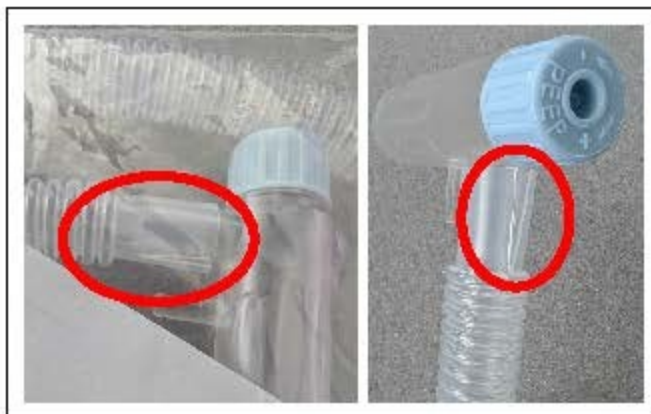
As part of our global market monitoring, we have become aware of cases in which obvious cracks in the hose of our VentStar Resus Neo and VentStar Resuscitaire were detected by the users prior to use. In no case we were informed of any negative effects on the health of the affected patients. However, this cannot be completely ruled out if such crack remains undetected.

**In case a cracked hose is used, the hose could fall off or leakage will occur. Depending on the leak, ventilation will be restricted and therapy could be delayed potentially resulting in desaturation, hypoxia or patient death.**

Our analyses revealed that affected hoses developed cracks shortly after the manufacturing and assembly process. Stress tests on “flawless” hoses have shown that they can safely be used as always.

**Fig. 1. Cracked hose with PEEP valve**

#### **1. Carefully inspect the hoses for damages prior to use according to the product's Instructions for Use (IfU).**

- 2. Discard products that show cracks (Fig. 1) or have a detached hose (Fig. 2). You do not need to return them to us.**

The affected circuits will be replaced free of charge by your local Dräger representative.

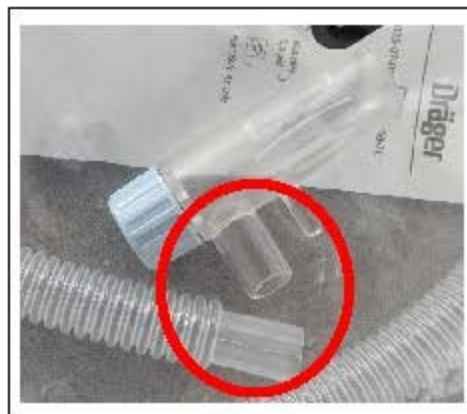
**Fig. 2: Detached hose/ PEEP valve**
