Urgent safety information
Corrective action
concerning
KayserBett OLAF paediatric care bed

08 Oct. 2024

Sender:
KayserBetten GmbH & Co KG, Rieper Str. 12, 29683 Bad Fallingbostal
SRN: DE-MF-000006910

Installation instructions for handcontrol position

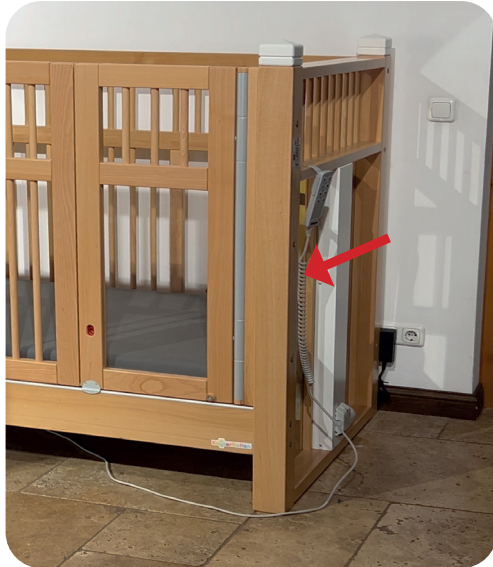
1. Position the hand control hook below the opening on the inside of the post at a height of 80 cm from the floor.

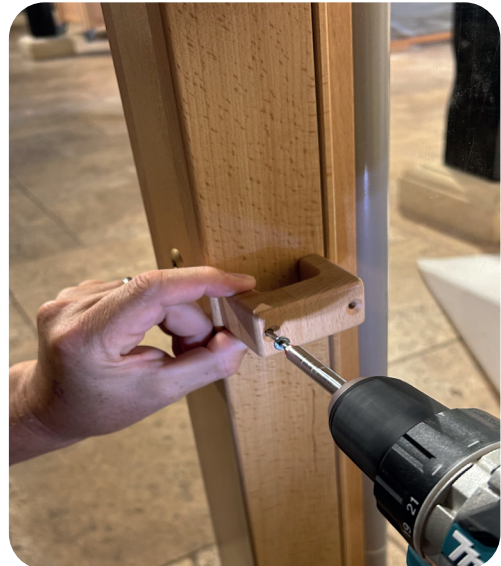
2. Screw the hand control hook in place using the enclosed screws.

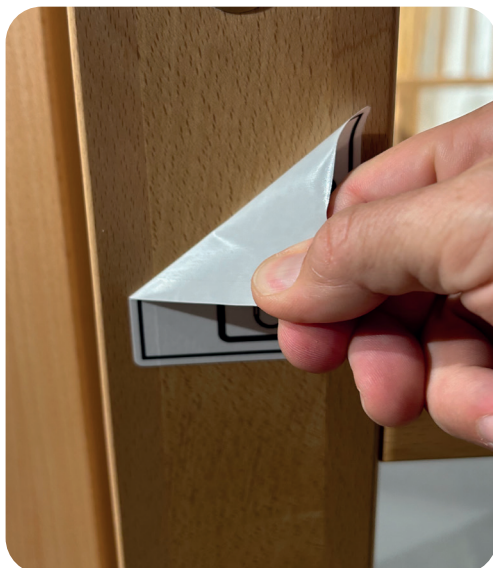
3. Entfernen Sie den Aufkleber vom Pfosten.

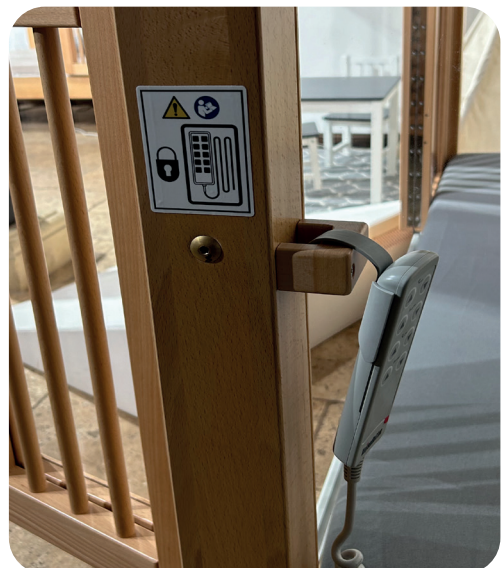
4. Kleben Sie den beiliegenden Aufkleber wie abgebildet an den Pfosten.

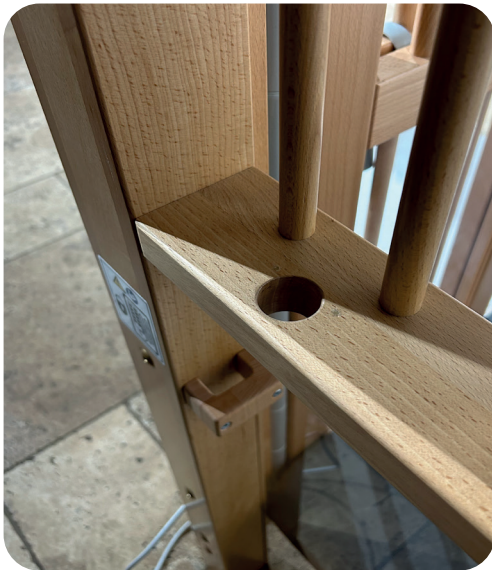
5. Remove the hand control the opening in the side frame.

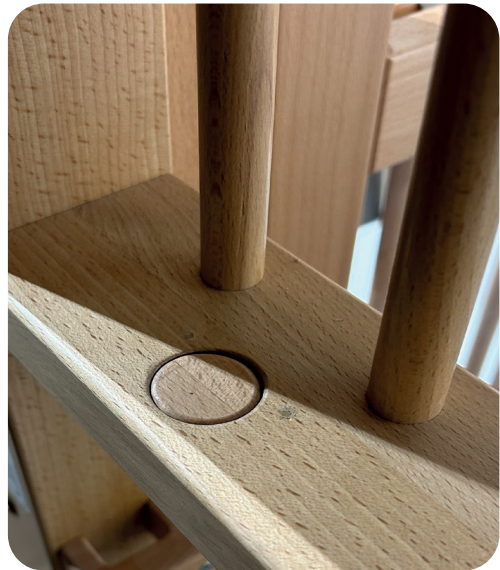
6. Position the wooden plug flush in the opening. Hold it in position if necessary.

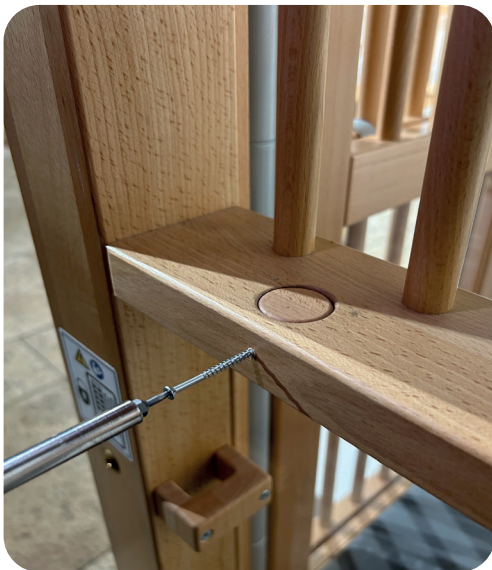
7 Screw the plug in place with the enclosed screws without pre-drilling.

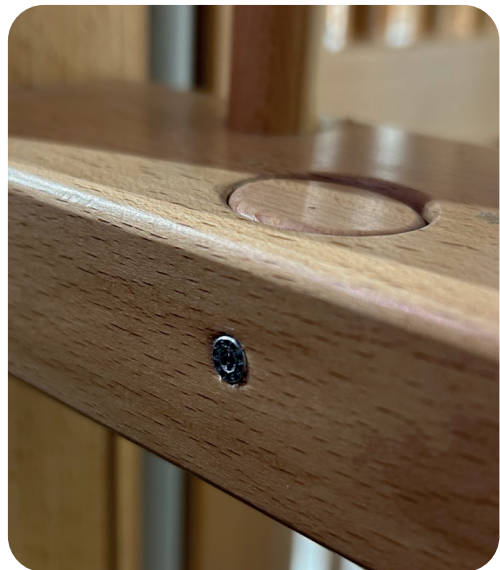
8. tighten the screw until the head is flush with the surface.
