Urgent Field Safety Notice (RECALL)

Guedel Airways

Urgent Field Safety Notice (FSN)

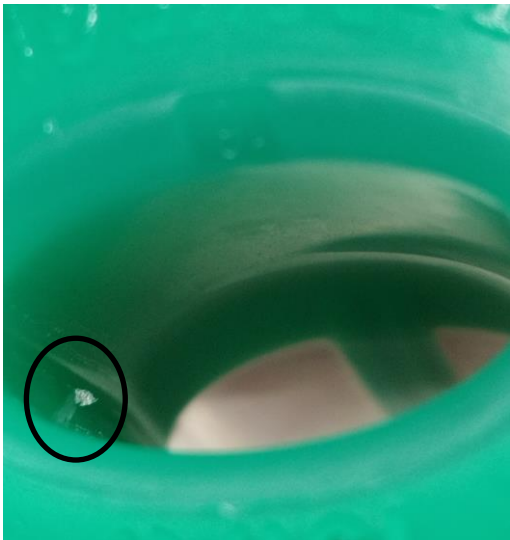
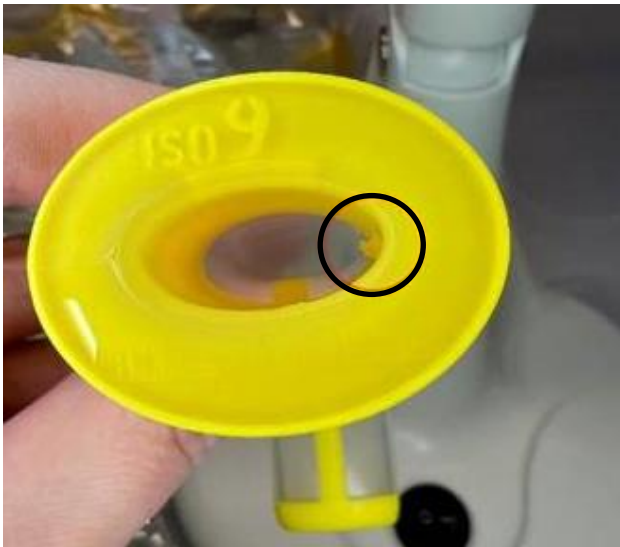
2. Reason for Field Safety Corrective Action (FSCA)*	
2.	1. Description of the product problem* During manufacture small plastic burrs have been identified inside the Guedel Airways, as shown below. <div style="display: flex; justify-content: space-around;">

2.	2. Hazard giving rise to the FSCA* The device is potentially contaminated with small plastic burrs inside the Guedel or packaging from the manufacturing process. If the burr becomes detached and is inhaled, it could result in potential complications such as airway obstruction, tissue irritation, inflammation and infection.

2.	6. Background on Issue A non-conformance was raised for plastic burrs found inside the Guedel Airway during manufacture. The fault was caused by damaged production equipment contacting the inside of the Guedel Airway, which has since been corrected with no further problems identified. Further evaluation of products and manufacturing records has enabled us to confirm the range of products and lot numbers under this FSCA. No reports of this problem have been reported from the market to-date.

2.	7. Other information relevant to FSCA N/A	
	3. Type of Action to mitigate the risk*	
3.	1. Action To Be Taken by the User* <div style="display: flex; justify-content: space-between;"> <input checked="" type="checkbox"/> Identify Device <input checked="" type="checkbox"/> Quarantine Device <input checked="" type="checkbox"/> Return Device <input type="checkbox"/> Destroy Device </div> <div style="margin-top: 10px;"> <input type="checkbox"/> On-site device modification/inspection <input type="checkbox"/> Follow patient management recommendations <input type="checkbox"/> Take note of amendment/reinforcement of Instructions For Use (IFU) <input checked="" type="checkbox"/> Other <input type="checkbox"/> None </div> <p>Please distribute this Field Safety Notice to all potential users of the Guedel Airway devices listed above, within your facility. This is for their awareness of the potential problem and to carry out the following actions.</p> <ol style="list-style-type: none"> 1. Identify and immediately quarantine any potentially affected products from the affected code and lot numbers listed above. 2. Please complete the Reply Form below to confirm the products you have identified, to arrange collection of the devices and a credit. 3. If you have no affected devices in stock, please confirm this using the Reply Form below. 4. Please return the Reply Form provided below to giedriusb@intersurgical.it, to confirm receipt of this notice and that the necessary actions have been taken. <p>Please note: This is a Recall.</p> <p>Please continue to report to Intersurgical any adverse events involving this product.</p>

3.	5. Action Being Taken by the Manufacturer	
	<input checked="" type="checkbox"/> Product Removal <input type="checkbox"/> Software upgrade <input type="checkbox"/> Other	<input type="checkbox"/> On-site device modification/inspection <input type="checkbox"/> IFU or labelling change <input type="checkbox"/> None
3	6. By when should the action be completed?	Two months from receipt of the FSN
3.	7. Is the FSN required to be communicated to the patient /lay user?	No
3	8. If yes, has manufacturer provided additional information suitable for the patient/lay user in a patient/lay or non-professional user information letter/sheet?	
	N/A
