FSN Ref: 2026-FSN-0000129

Date: 2026-03-31

URGENT Field Safety Notice
Risk of Leakage when using Purge Cassette Gen 1

1.	4. Device Model/Catalogue/part number(s)* 0043-0002; 0043-0003; 0048-0014; 0046-0011; 0550-0002; that includes Purge cassette Gen 1(0043-0001 and 0043-0009)

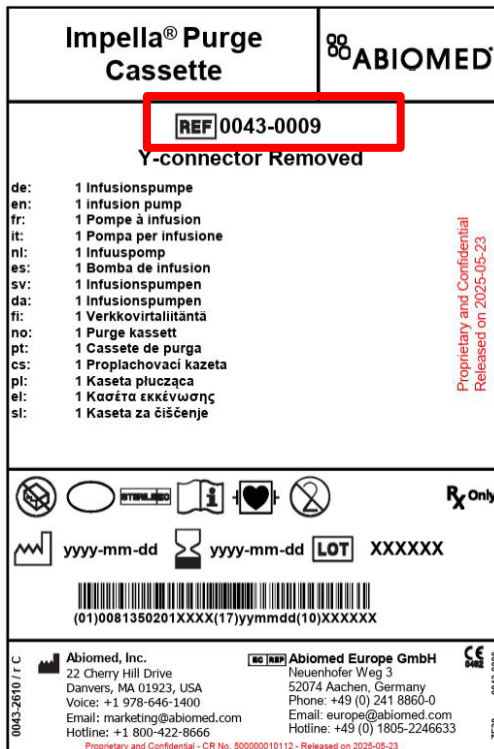
- For Impella 5.5 pump set, not all pump sets are impacted. **Impella 5.5 pump set (1000482) is not impacted.**
- For Impella 5.5 pump set (0550-0002) and Impella RP (0046-0011), open the pump set and look for the purge cassette with code (0043-0009) as shown in the image below:

- ✓ :1000851: No action required
- ✗ : 0048-0014: open the Pump-Set, remove the Gen 1 Purge Cassette (0043-0009), and follow the instructions in **ACTIONS TO BE TAKEN BY CUSTOMER/USER:**

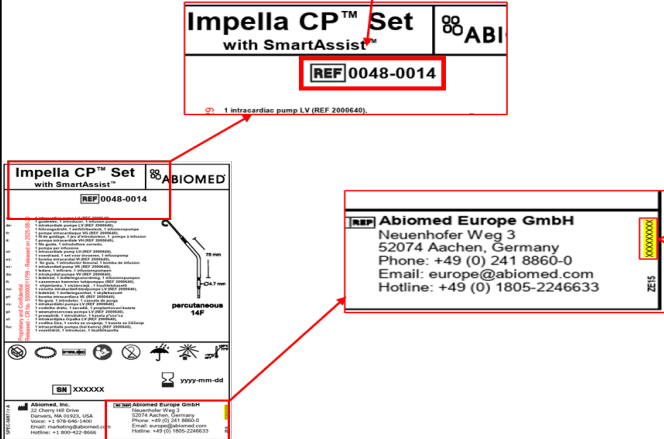
Step 1: Check if **REF 0048-0014** is in the label

Step 2: Check Internal number.
